Chartered Surveyors

Sample Building Survey (Level Three Report)

**A Building Survey
on
Brockley
Bristol
BS48**

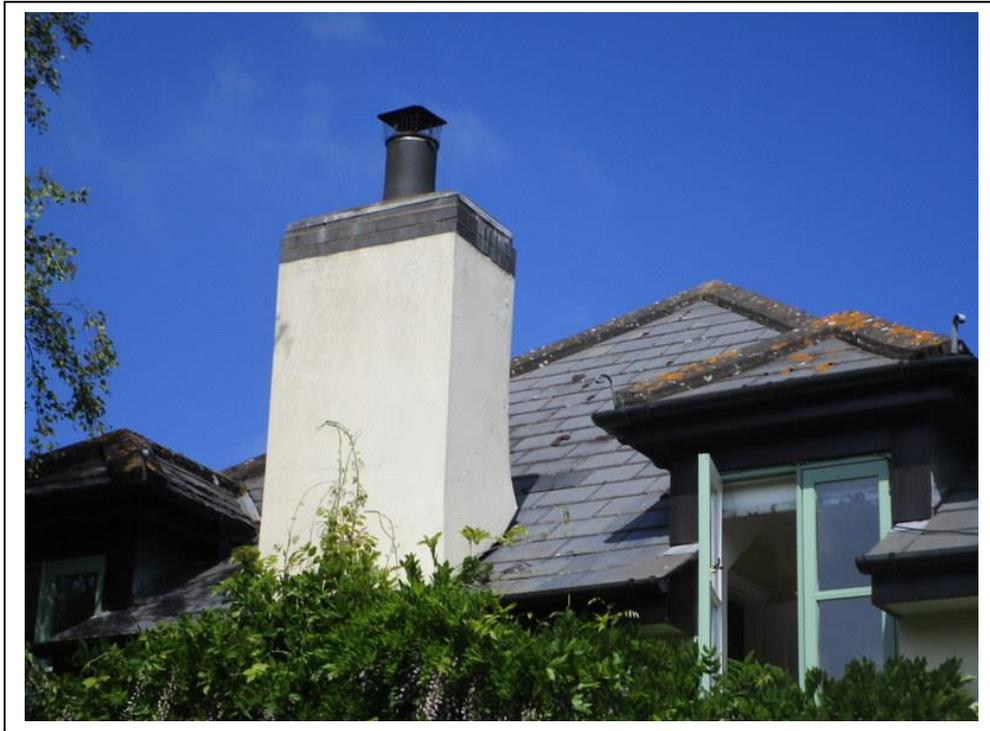
Right side chimney.

- Repair the chimney to the right side of the property. This may involve repair or replacement of render finishes and flashings and attention to detailing around the flue outlet.

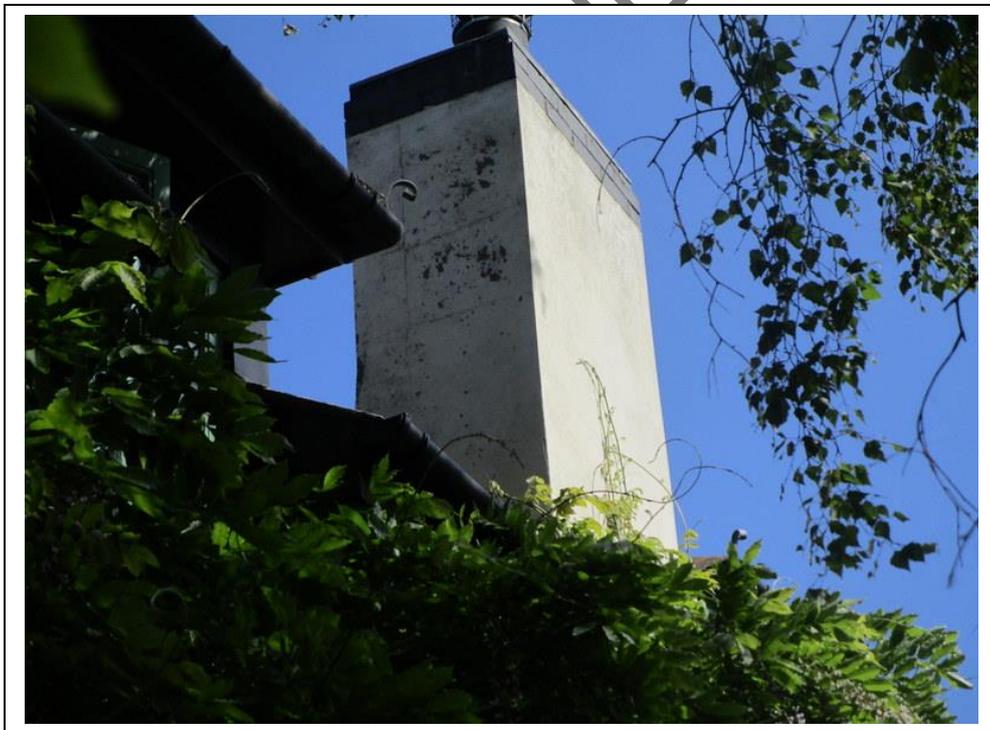
Deterioration to paint finishes and slight cracking affecting the front part of the chimney.

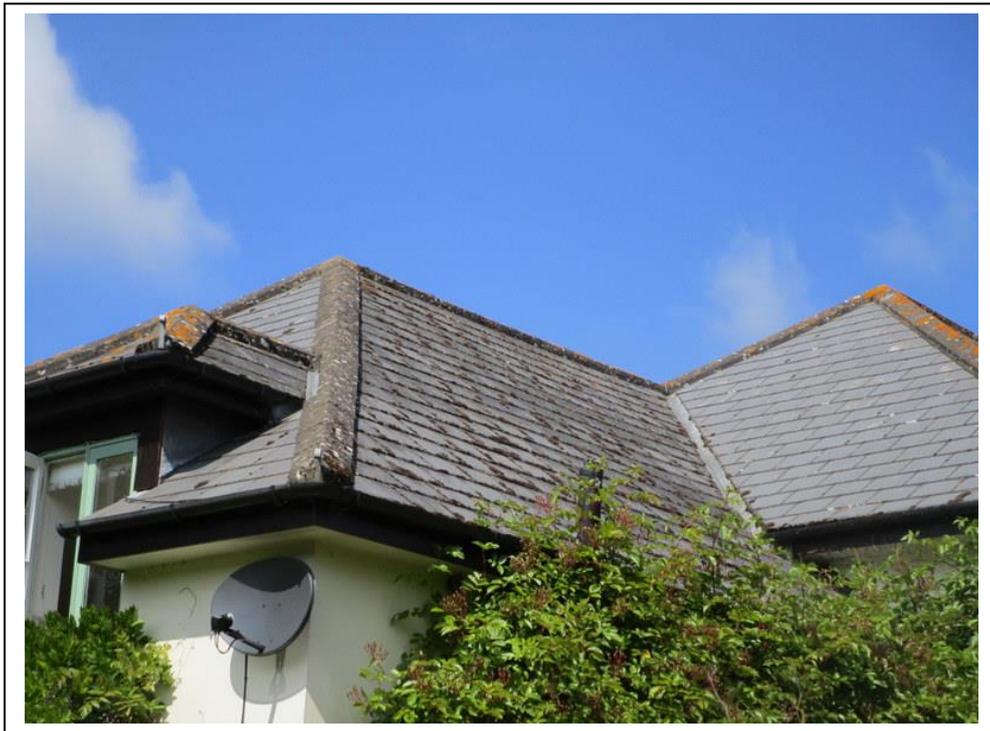
Roof coverings and valley structure around the right side extension. Note moss growth on the rear-facing roof and potentially vulnerable detailing around the side dormers.

- Undertake minor works of maintenance in respect of the roof coverings. Replace any slipped or damaged slates, maintain leadwork and re-bed hip and ridge tiles in new mortar when necessary. Improve ventilation to the eaves and loft spaces to reduce condensation risk. Maintain detailing, cladding, joinery etc to dormer windows to the right side extension.

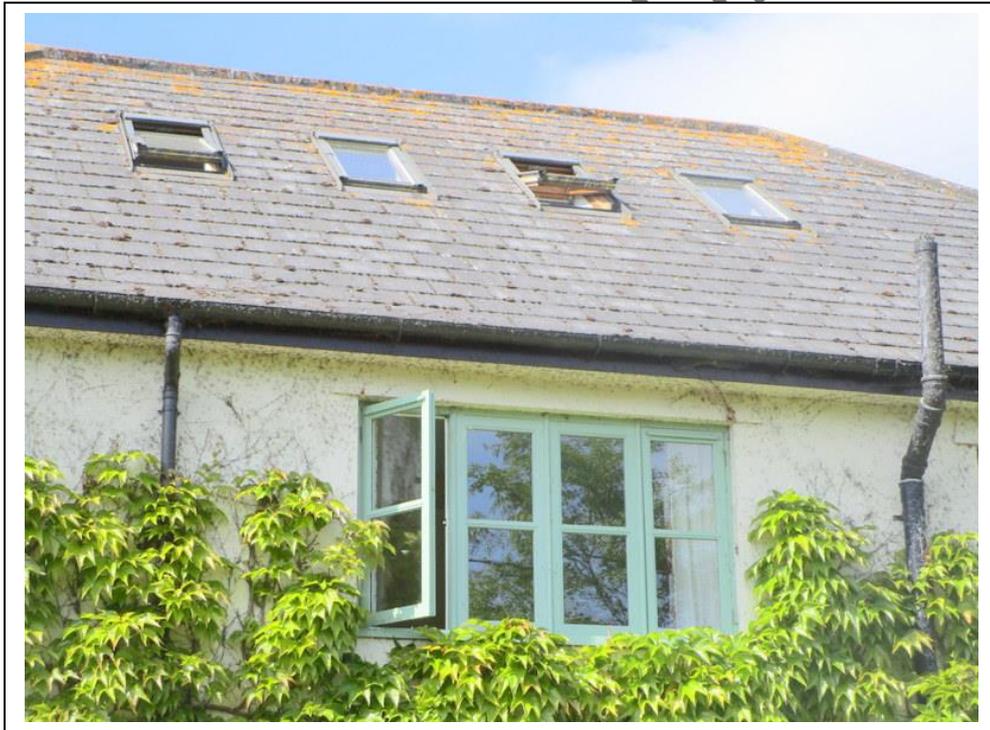
Roof coverings to the rear showing four Velux roof-light windows, eaves joinery and rainwater fittings.

- Replace Velux roof windows to the rear.
- Repair or replace eaves joinery as it becomes affected by rot.
- Redecorate externally.
- Repair internal walls and ceilings as necessary and complete internal works of redecoration. Any slight cracks should be filled and the walls prepared as necessary.

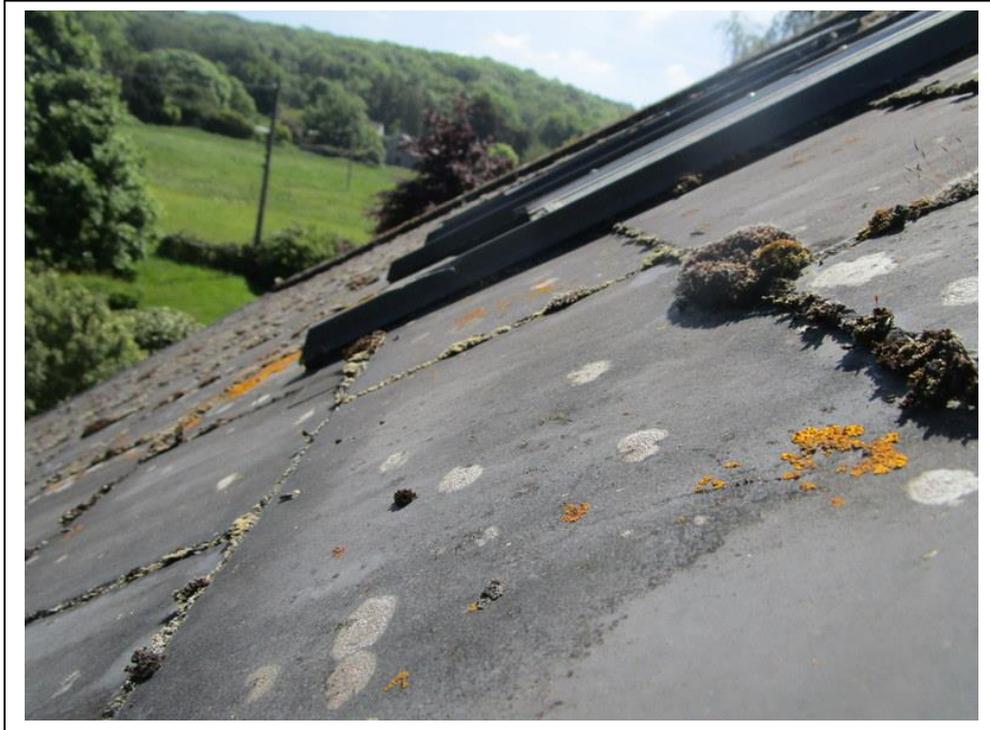
Slate roof coverings viewed from one of the Velux roof-light windows showing again moss and lichen growth.

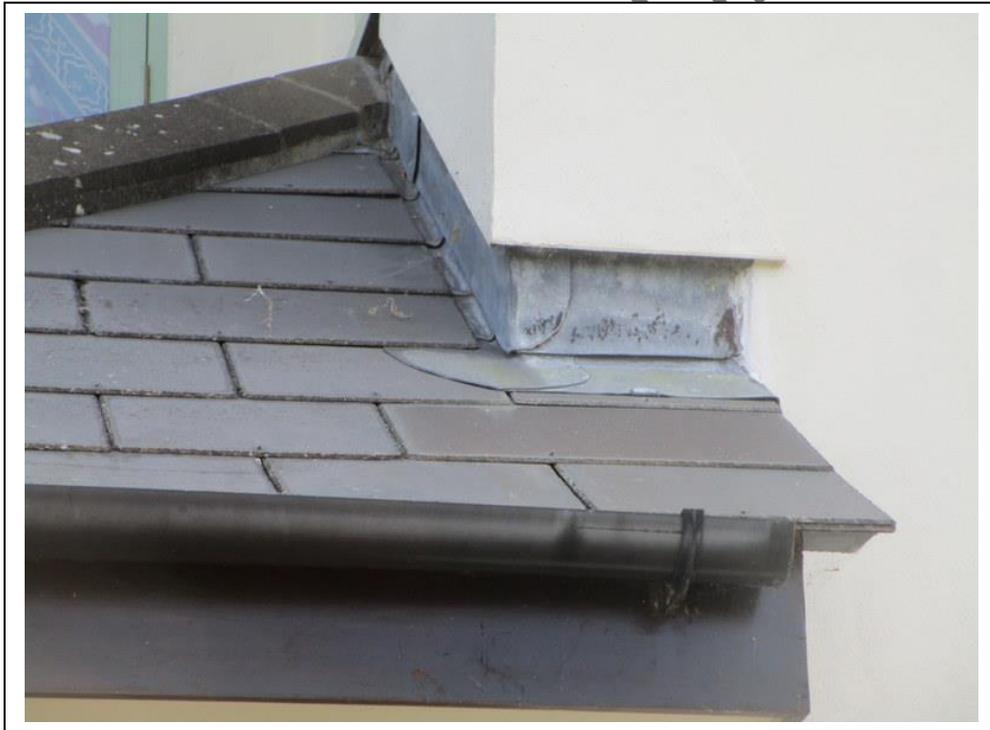
Neat and satisfactory leadwork around the edge of the front porch. Note missing end section to gutter and faded plastic.

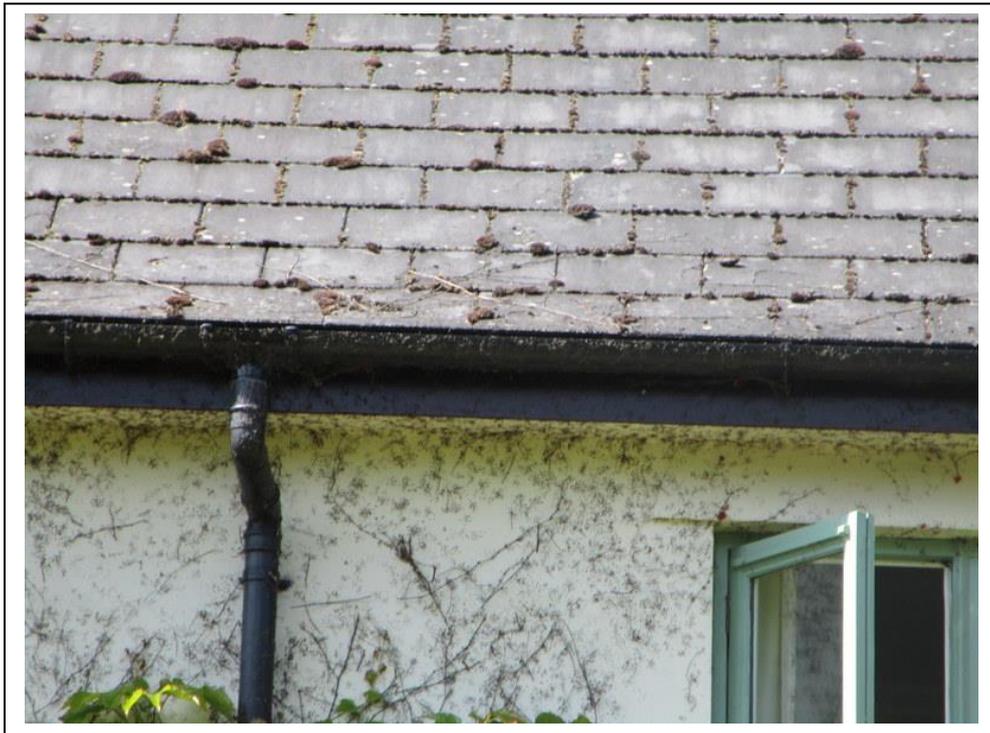
Roof slates to the lower part of the rear roof showing also plastic rainwater gutters. Wall finishes have been spoiled by vegetation.

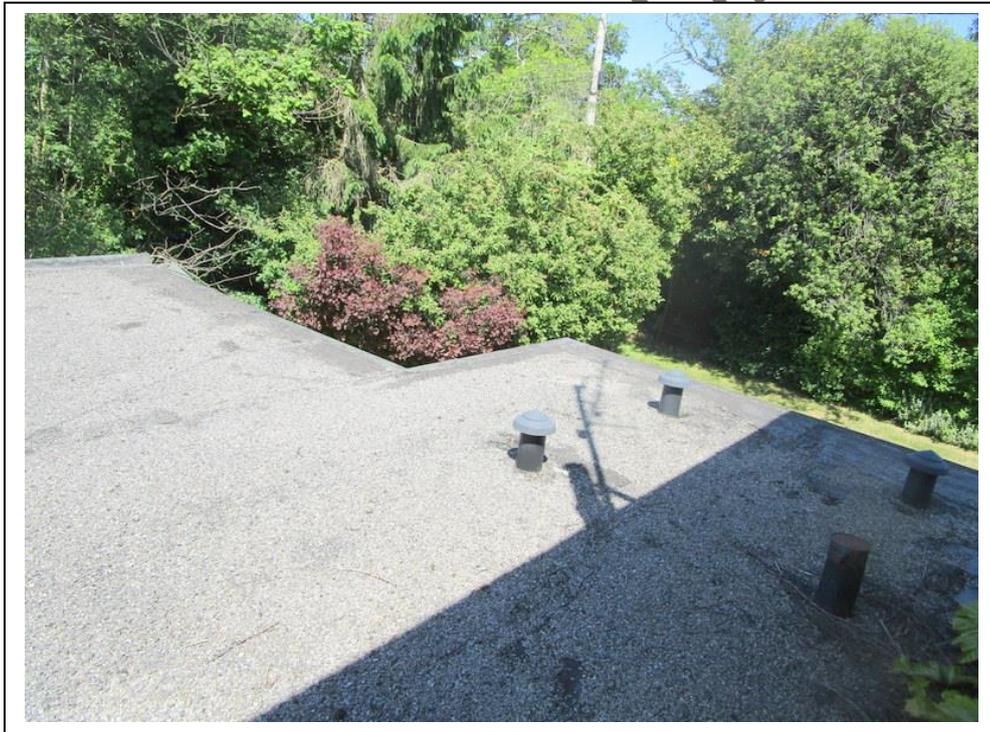
Flat roof coverings above the rear part of the garage and utility extension. Note provision for ventilation to the flat roof. One of the vents has a missing rain-cap.

- Cut back or remove creeper growing around the main walls.
- Fit missing rain-cap / cover to vent pipe to utility roof.
- Consider lowering of ground levels or removal of planters to the front to reduce risks of dampness.

- Renew the flat roof coverings above the garage and utility. Repairs may be needed in the short term if leaks appear.
- Replace rainwater gutters and pipes.

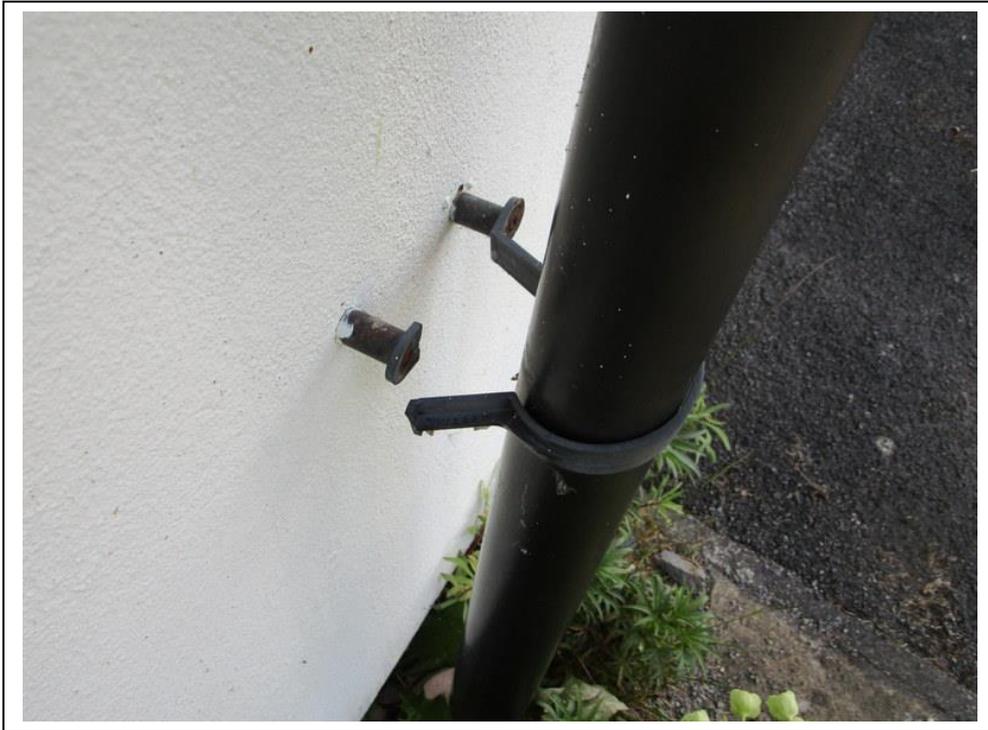
General works of maintenance will be required in respect of rainwater gutters and pipes including replacement of broken fixings. Plastic gutters, pipes etc will become brittle over time.

- Check all rainwater fittings in heavy rain to help schedule and prioritise maintenance. Repair damaged fixings, reseal joints and remove any moss from within gutters and pipes.

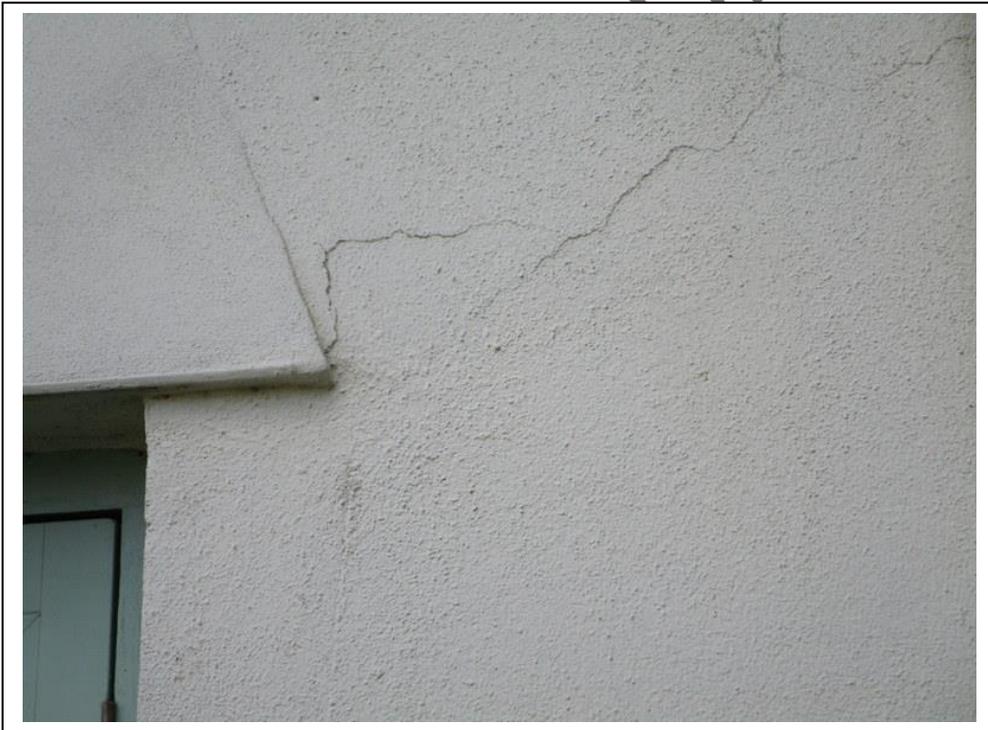
Slight horizontal cracking was noted to some of the walls including the front wall of the property. This could be connected to corrosion of wall ties or other metal fixings embedded within the walls. If the cracks progress or worsen, further investigation of the condition of wall ties should be carried out. You should be aware that corrosion of wall ties is a fairly common problem in properties of this age and the need for future replacement cannot be ruled out.

Slight cracking was noted, as shown here to the front of the property.

- Check external walls for any signs of cracking and repair render finishes as necessary.
- Repair windows and doors prior to redecoration. Plan for replacement in the medium or long term.

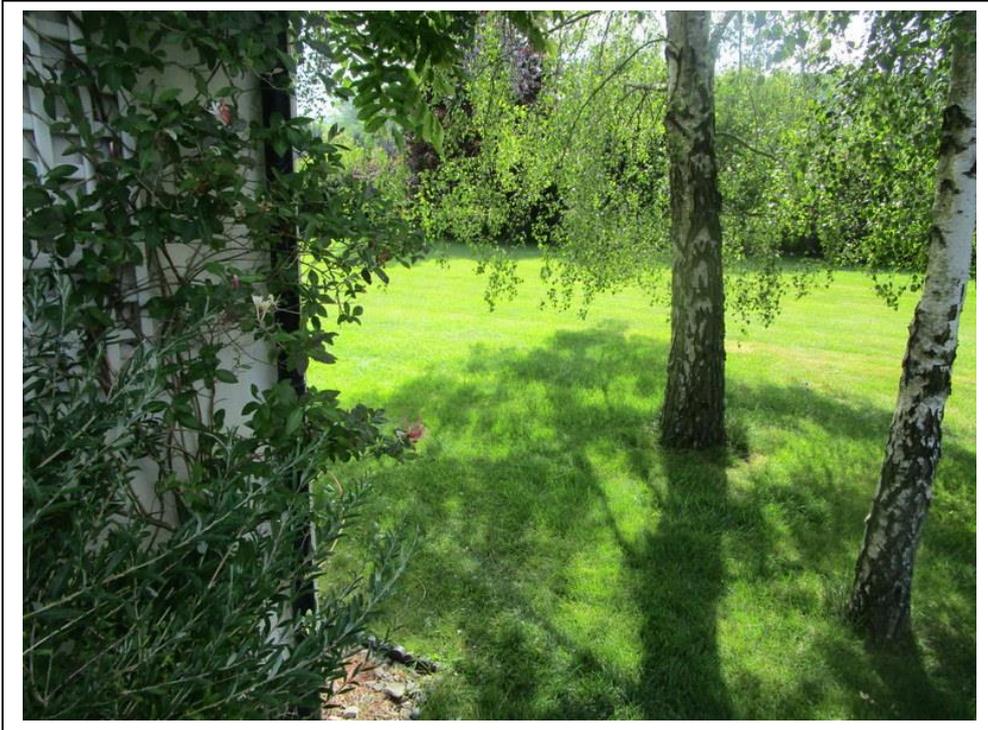
There are silver birch trees growing close by to the right side of the property and a poplar tree beyond the left side boundary hedge. All trees have a capacity to absorb water and this can cause contraction of the soils in dry summer months and subsidence. The silver birch trees will present an increased risk as they grow over time and they would probably be best removed. Removal should be carried out over a period of years to avoid excessive hydration of the soils which can also cause problems.

There are risks of structural movement due to the proximity of trees close by.

- Remove combustible materials from around gas bottles and the oil tank.
- Maintain sanitary fittings and plan for replacement in the medium term.
- Obtain a CCTV drainage test to check the condition of underground drainage pipes. Be aware that old pipes in the rear garden may need to be repaired if they are cracked or broken. Any debris or blockage within the pipes should be cleared by rodding or jetting. Decommission the disused septic tank or secure the lid to prevent accidental injury.
- Be aware that any soakaways which serve the surface water / rainwater downpipes may no longer be in fully satisfactory working order and the need for reconstruction cannot be ruled out.
- Maintain boundary hedges and repair the timber agricultural fence to the right side. Remove the silver birch trees which are growing close by to the right side.

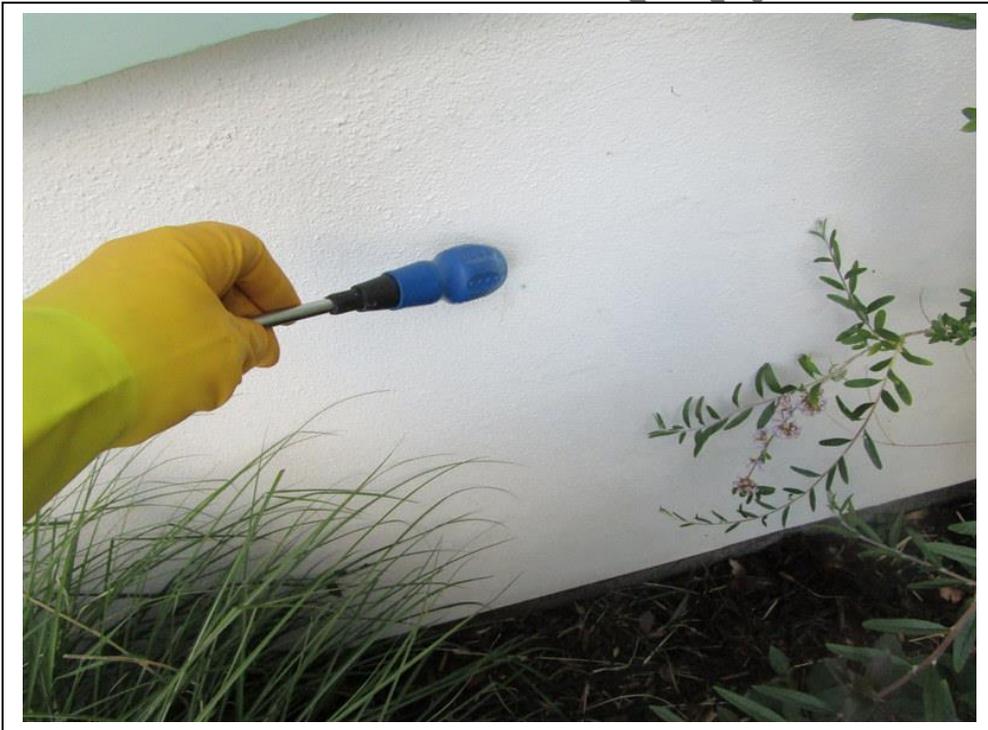
Render wall finishes were found to be generally sound and well-bonded to the masonry beneath.

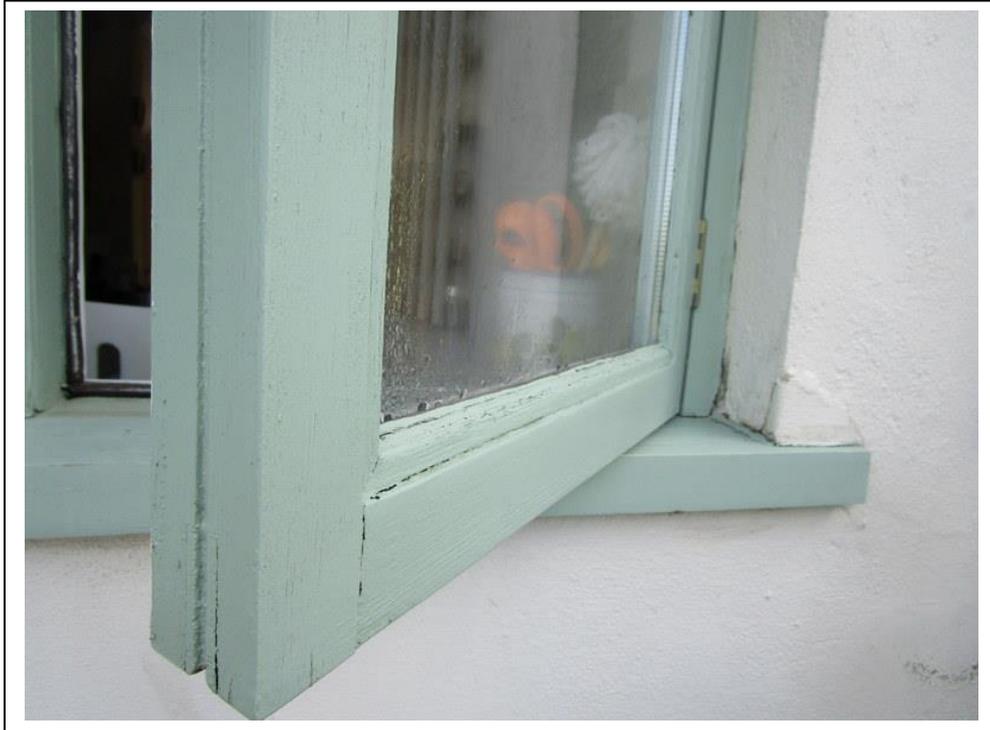
Windows are of mostly timber casement construction with laminate glass. Note failed glazing until to the kitchen window as shown here.

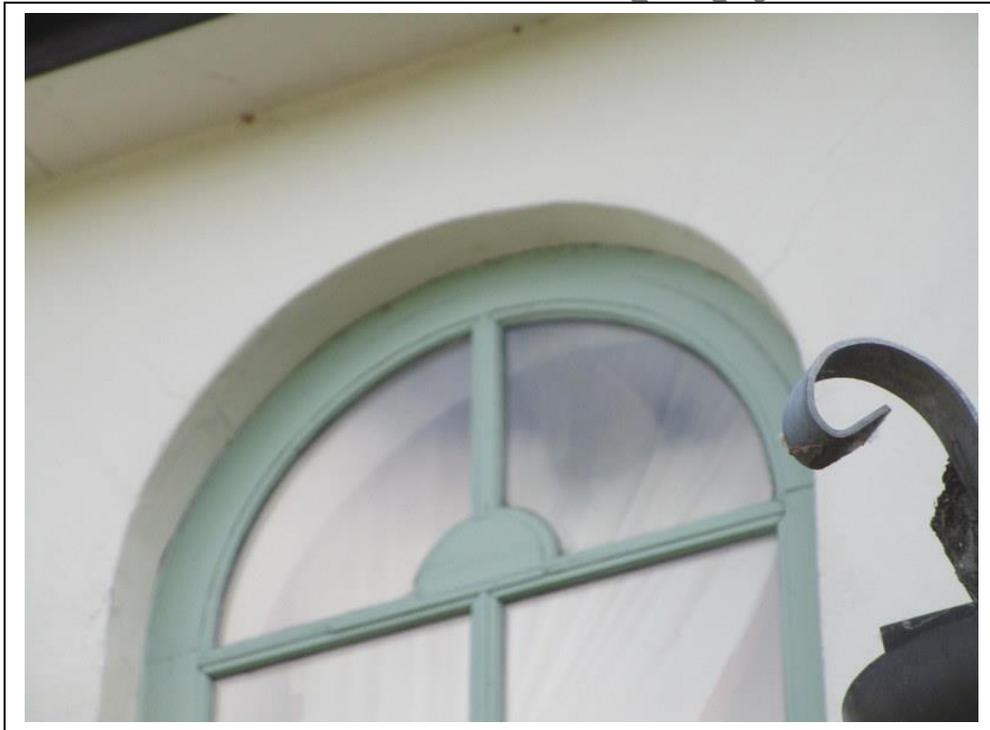
Failed glazing units were also noted to the arched window adjacent to the stair.

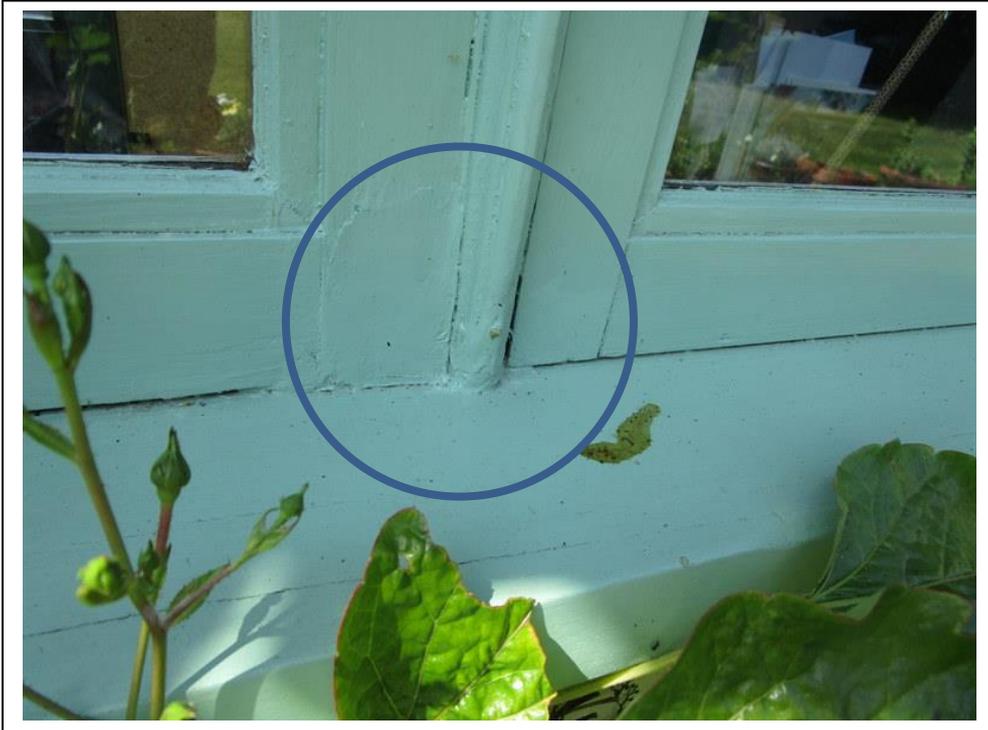
Patch and filler repairs have been carried out to both windows and doors prior to last redecoration.

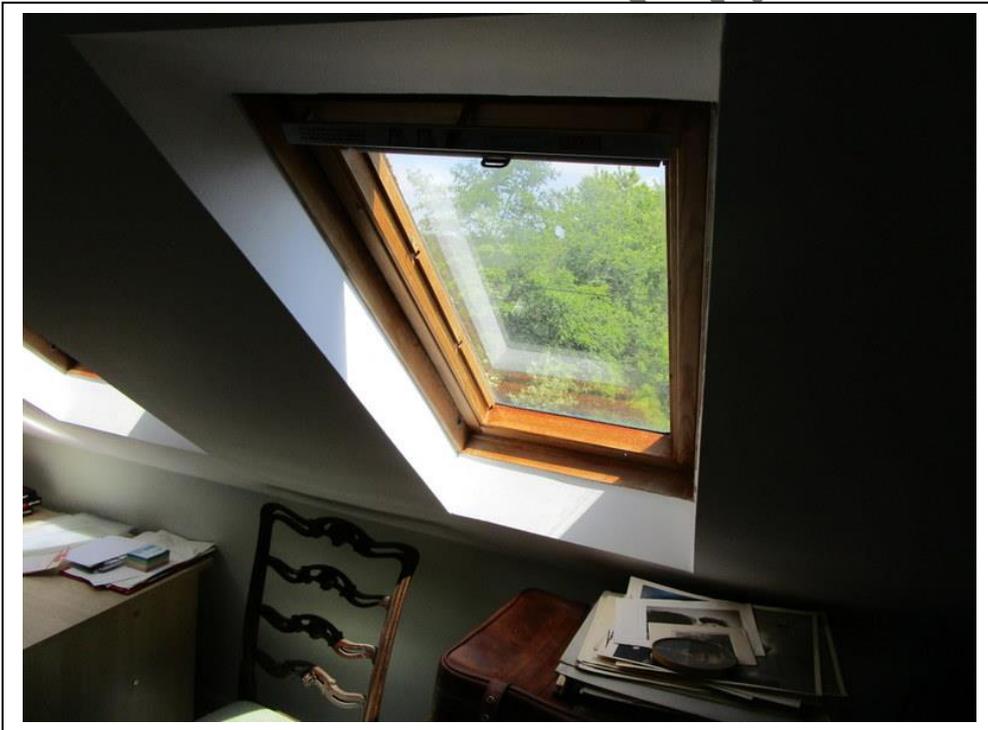
The roof-light windows are old and will need to be replaced in due course.

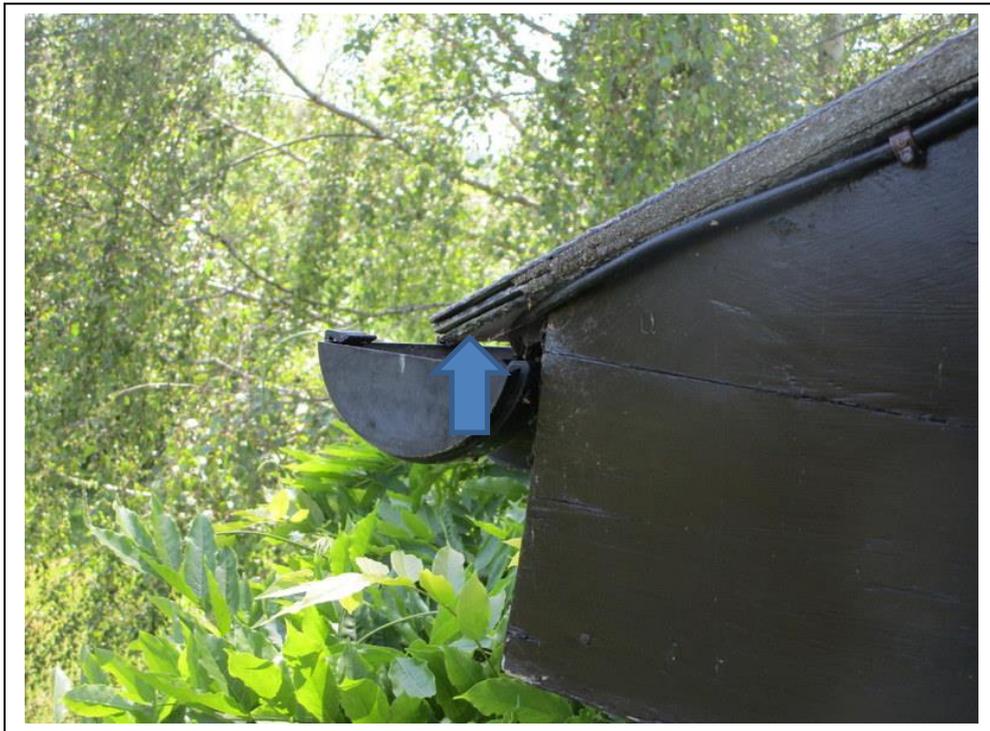
Eaves joinery will be vulnerable to rot and is likely to require repair in the future. Note satisfactory installation of the lower slate courses with triple covering visible in the eaves.

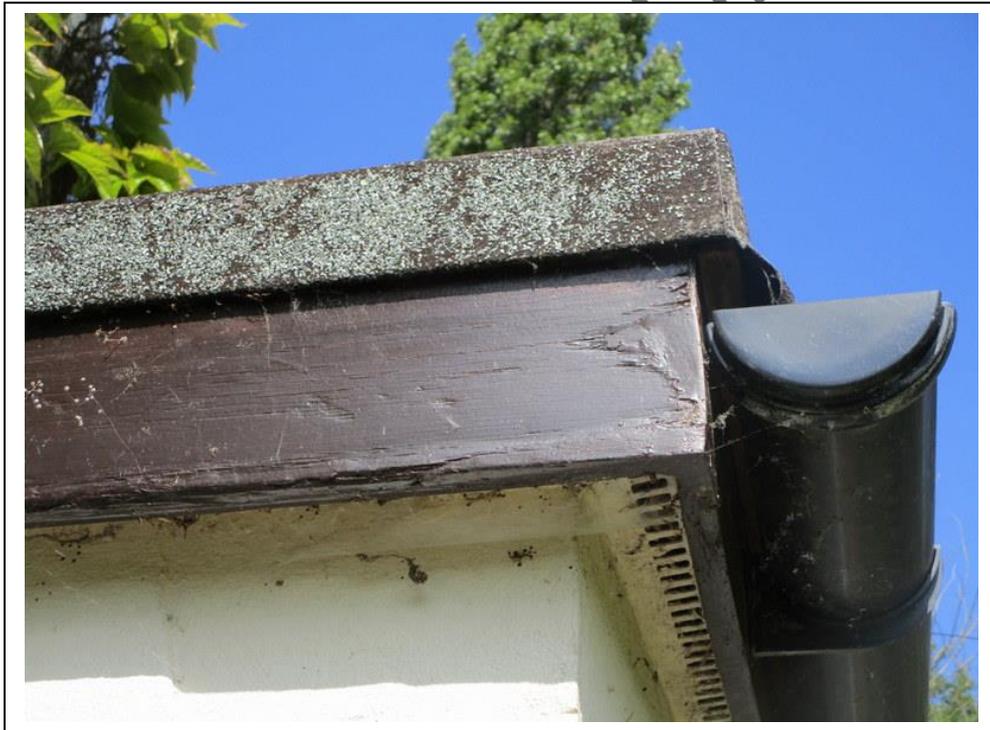
Deterioration affecting fascia joinery around the utility room. Note presence of eaves vents.

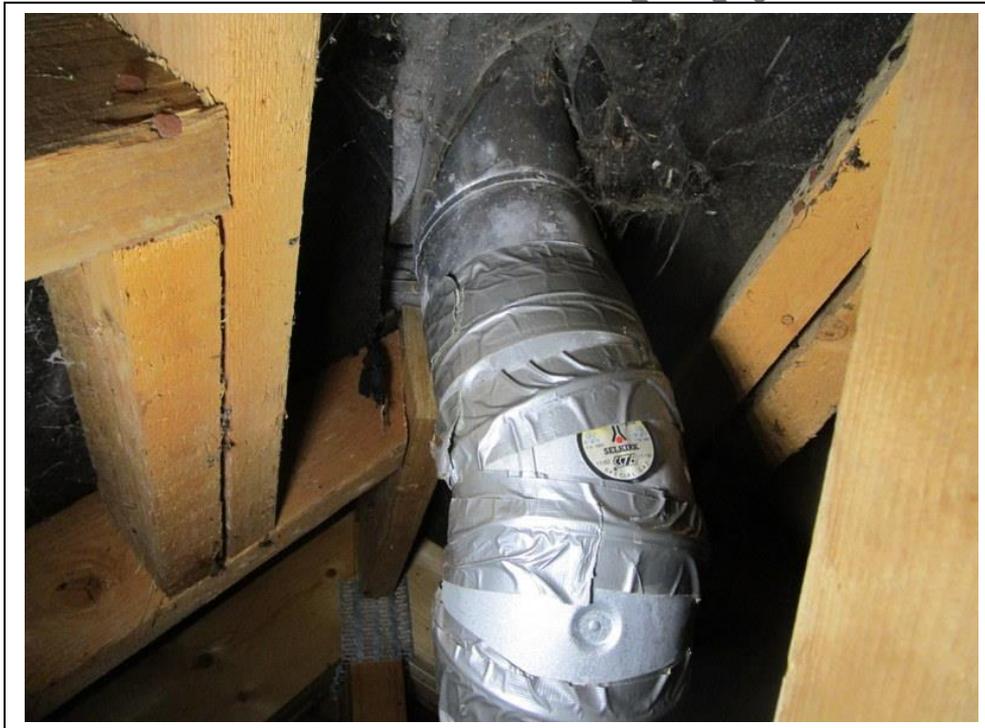
Flue outlet serving the gas fire in the snug. This should be checked by a qualified contractor before use and, as a precaution, extra bracket fixings provided.

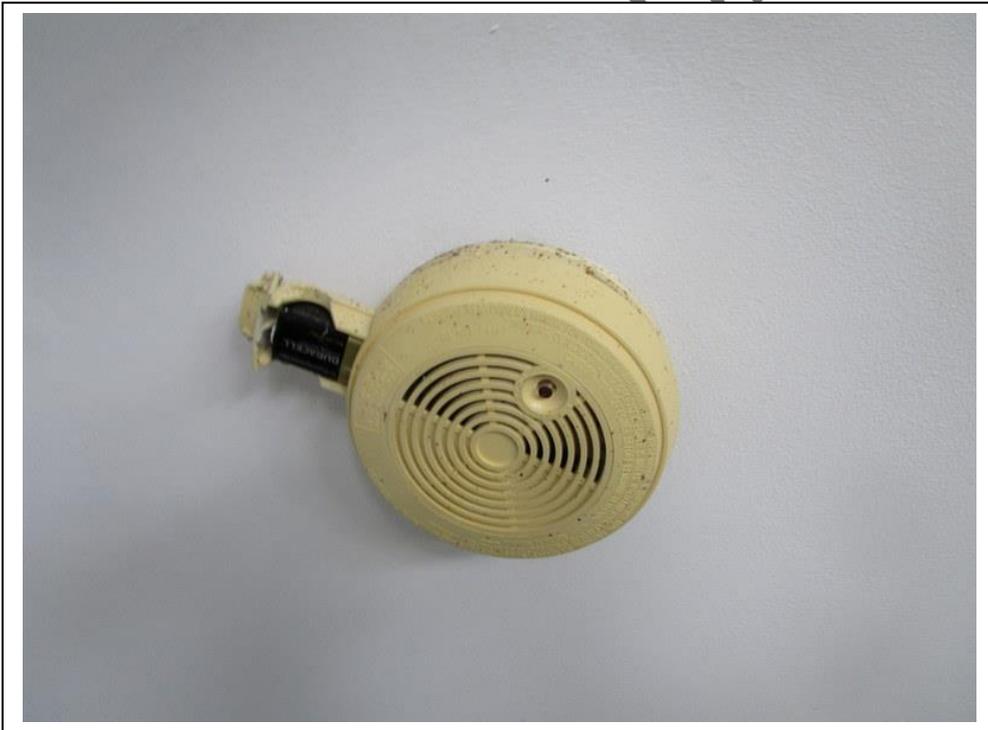
A new fire detection and alarm system should be installed.

- Obtain a full electrical test and report and undertake all / any recommendations for improvement.
- Install a full and good quality fire detection and alarm system and carbon monoxide alarms where gas, oil or solid fuel appliances are present.

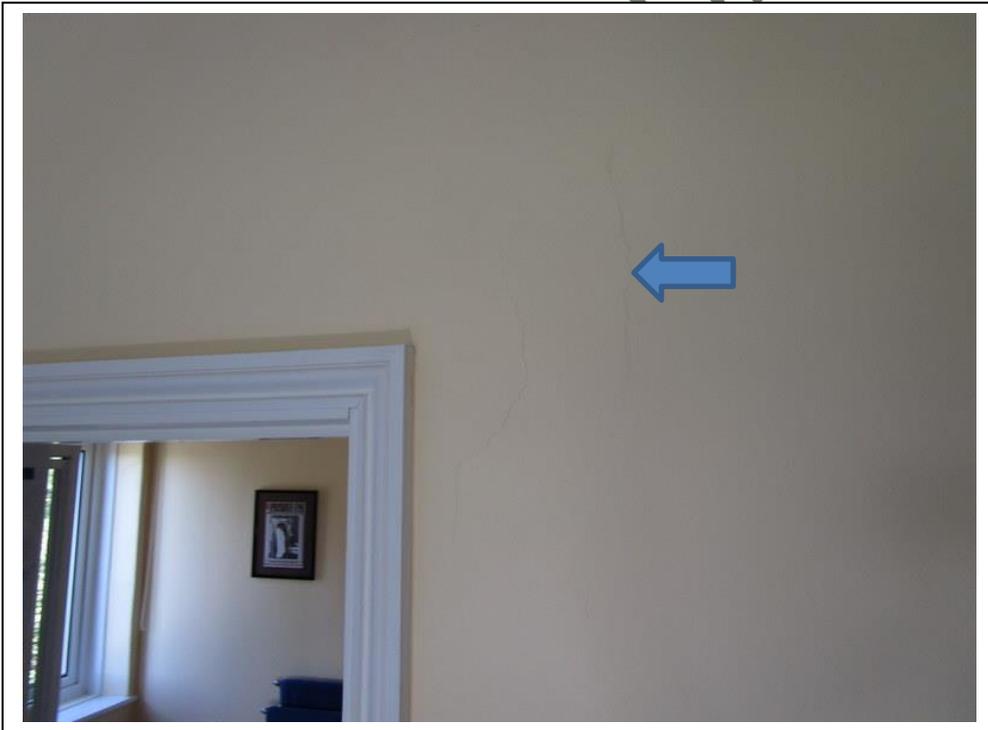
Cracking was noted to some internal walls. The cracks are slight and are unlikely to indicate serious structural problems.

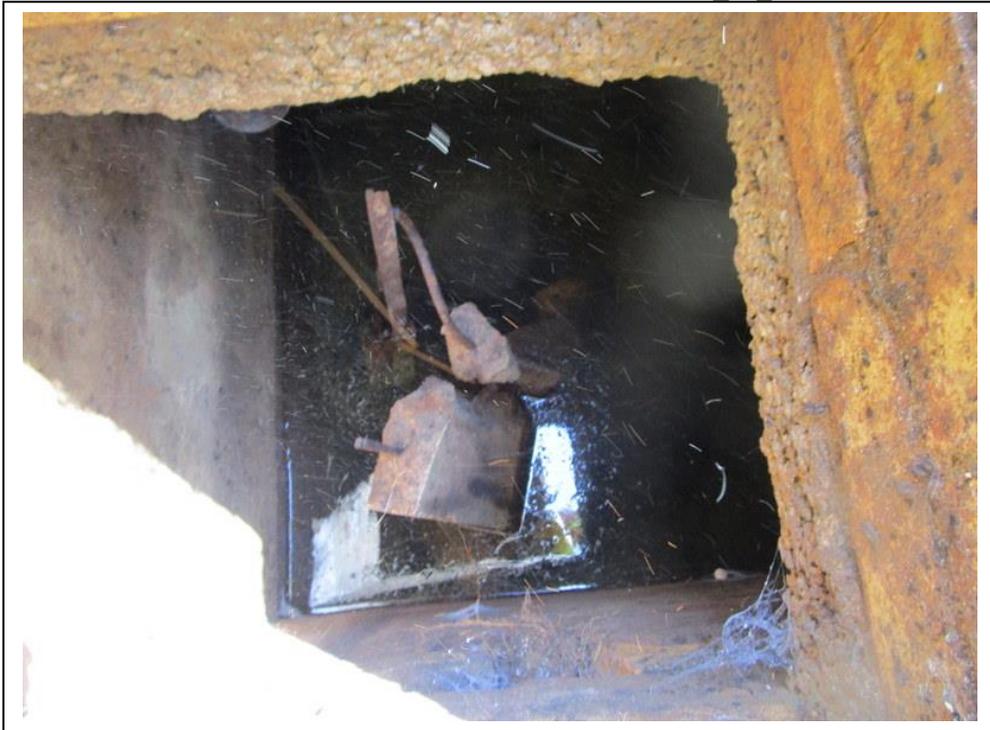
It appears that the property was originally served by a septic tank private drainage system which remains in the garden. Assuming the tank is no longer in use, it should be decommissioned and removed. Alternatively, or as a short-term measure, it is essential to ensure that the lid is secured to prevent accidental entry.

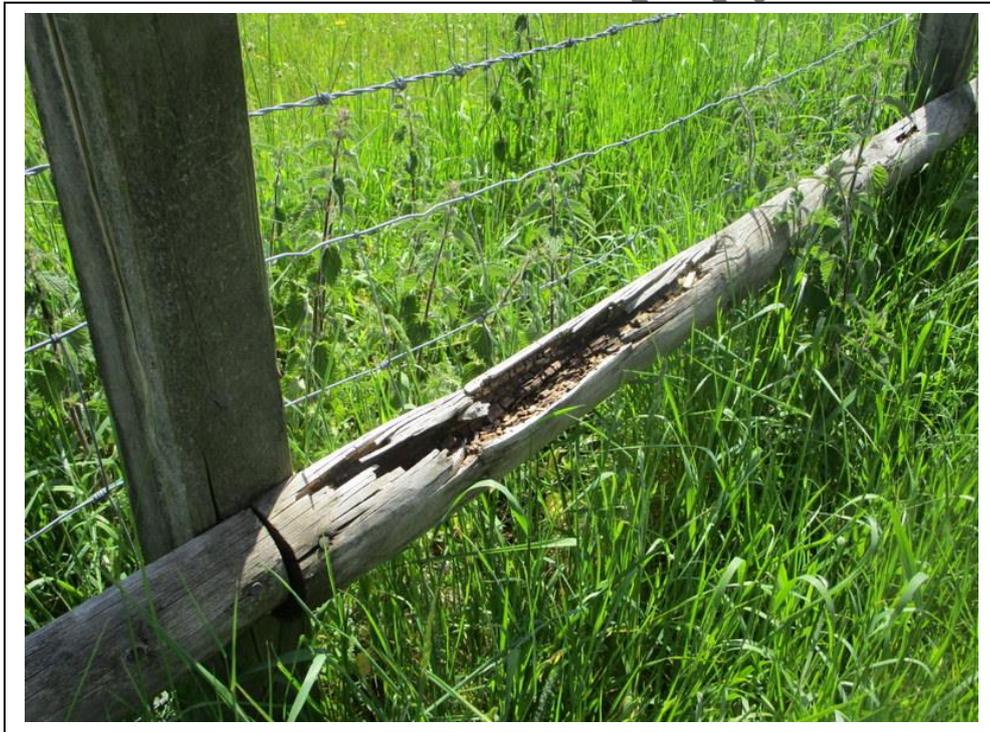
The fencing should be repaired in the short term and replaced in the medium term.

- Maintain garden areas and boundaries. Replace the timber fence to the right side.
- Resurface the drive.
