RICS Home Surveys

Survey level two: HomeBuyer report - Survey and Valuation

3rd September 2019

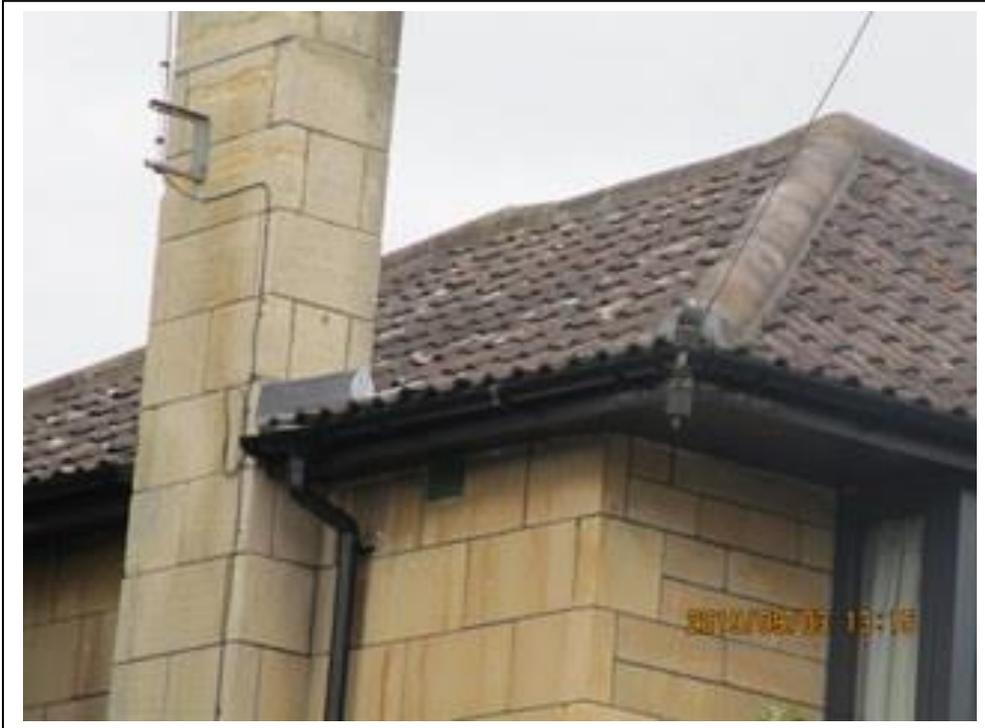
The original roof tiles were reused when the roof was repaired and reclaimed clay tiles of a matching style were fitted to the roof of the extension. Although the tiles are old, they remain in satisfactory condition. Ridge and hip tile pointing at the top and corners of the roof is satisfactory and no urgent repairs are required.

Roof tiles to the left side of the property showing also black plastic rainwater gutters and downpipe and stonework to the upper walls and chimney.

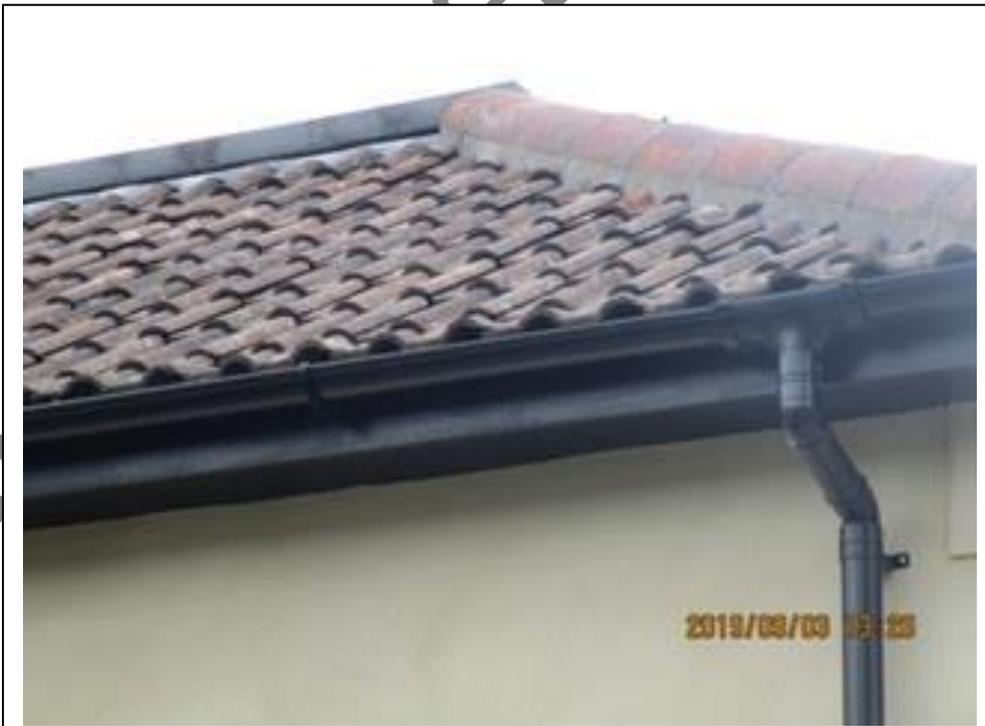
Roof coverings to the right side of the property showing again rainwater fittings and also edge detail to the flat roof.

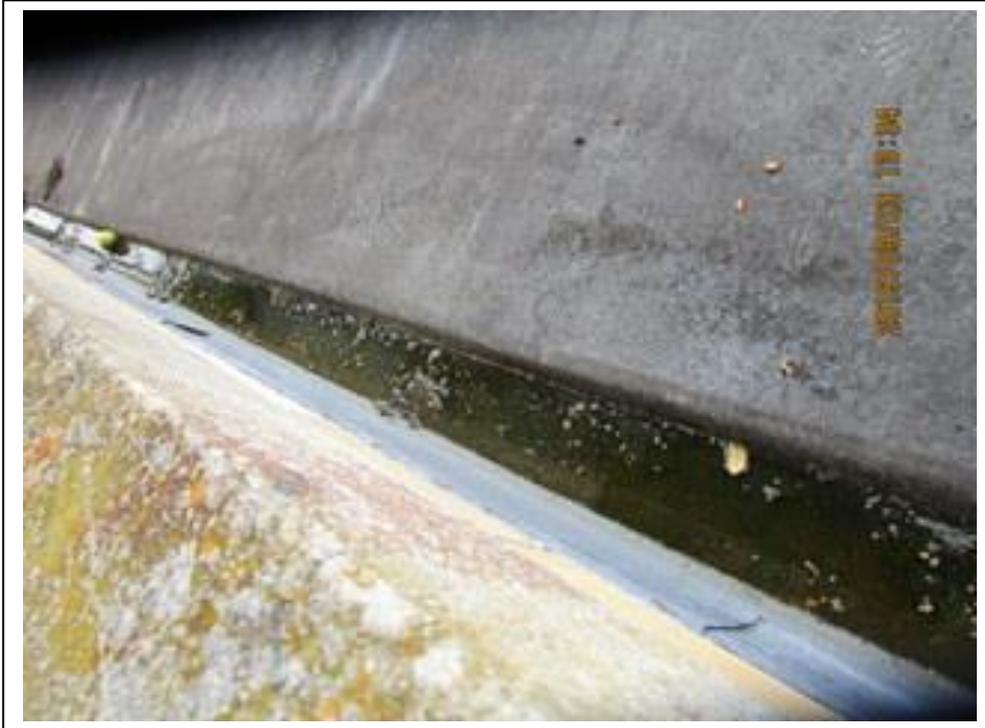
As described in Section E2 above, the channel gutter set within the flat roof of the rear extension has not been constructed to a satisfactory fall and signs of ponding / stagnating water were noted.

Ponding water in the rainwater drainage channel to the front part of the rear extension.

Ponding water was noted in the channel drain to the front part of the roof of the single storey extension due to inadequate falls. Debris from within the gutter should be cleared and consideration should be given to installation of a second outlet to the left side.

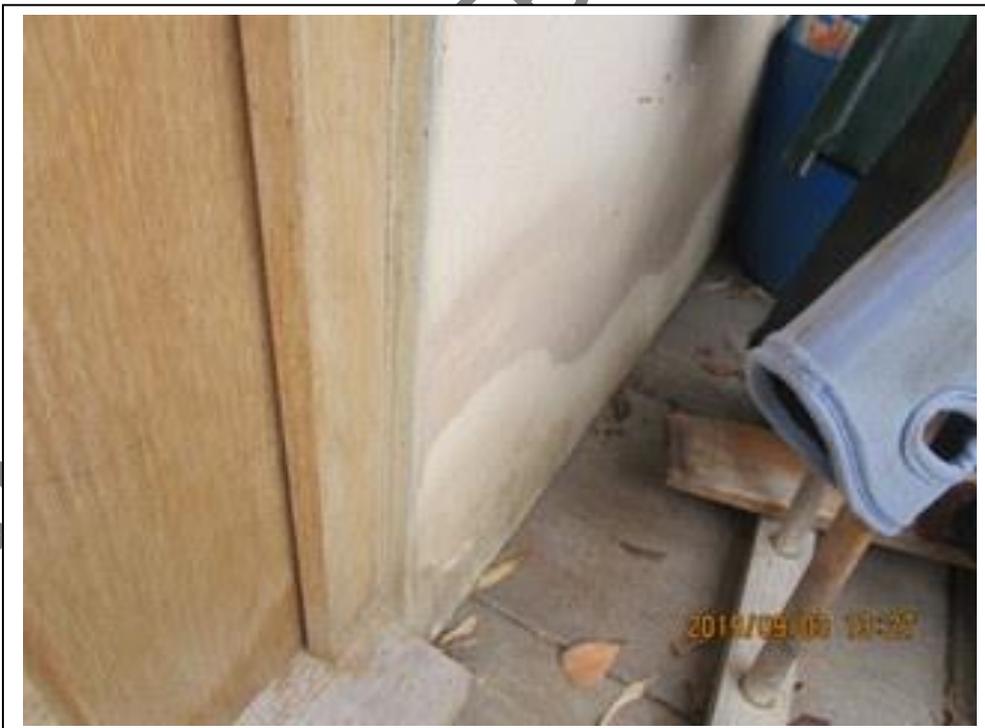
The exposed stonework to the older parts of the property and to the front wall of the right side extension is satisfactory with no repairs required. The render finishes to the right side are adequate although there are some imperfections and minor damage, for example around the electricity meter housing and slight discolouration above ground level, possibly due to the absence of a bell cast or drip-detail to the lower edge. The render extends to ground level and this increases the risk of dampness in the outer wall and wall finishes. Render finishes are an economic type of wall finish which will have a more limited life expectancy than stone cladding etc.

Discolouration affecting the render wall finishes to the lower part of the right side wall.

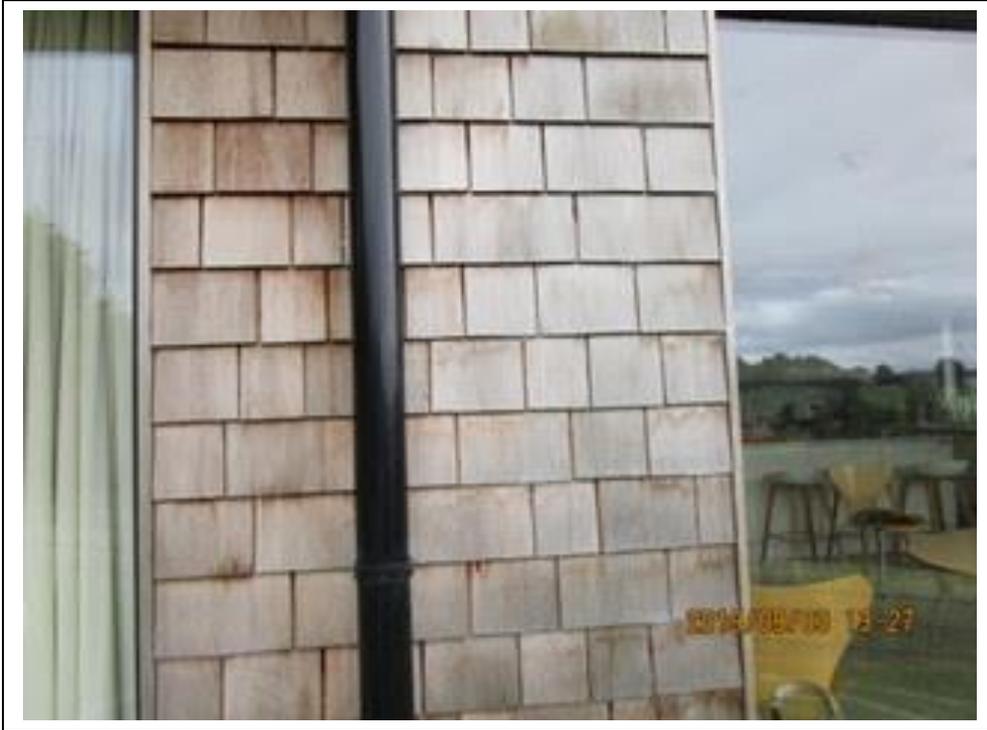
No serious defects were noted in respect of the cedar shingle cladding to the left side of the rear extension. Cedar shingles should have a reasonable life expectancy although again, probably shorter than a natural stone or block finish.

Cedar shingle cladding to the left rear part of the rear extension.

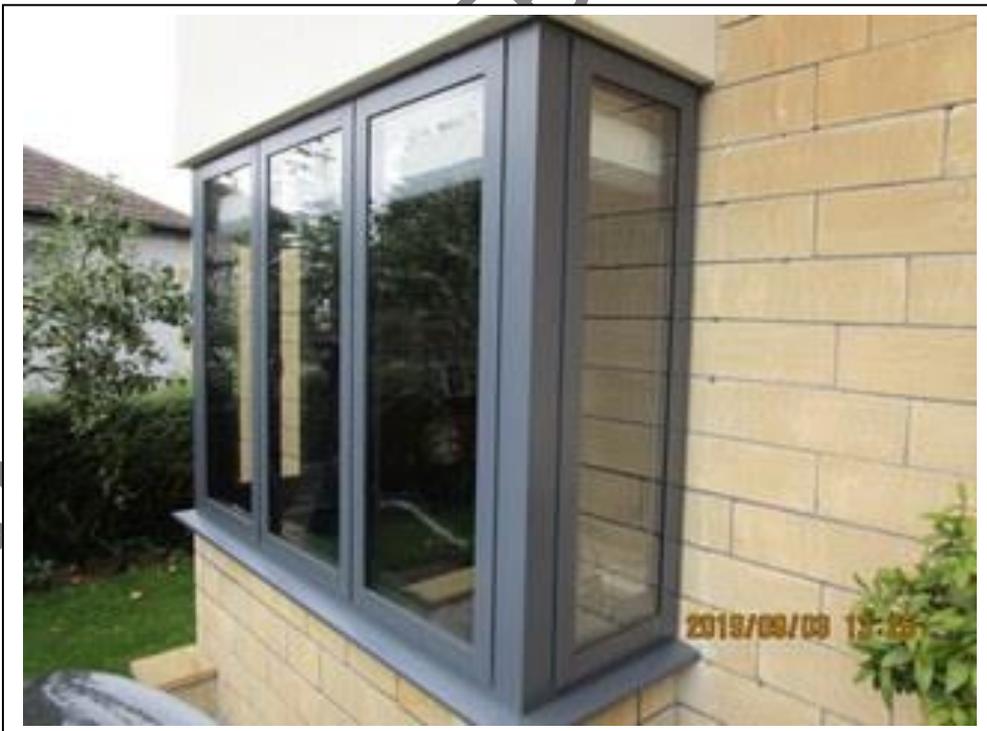
The windows are of a satisfactory quality and they are in satisfactory condition. Where tested, they were found to open and close without sticking or binding.

Windows are of modern double-glazed coated metal construction.

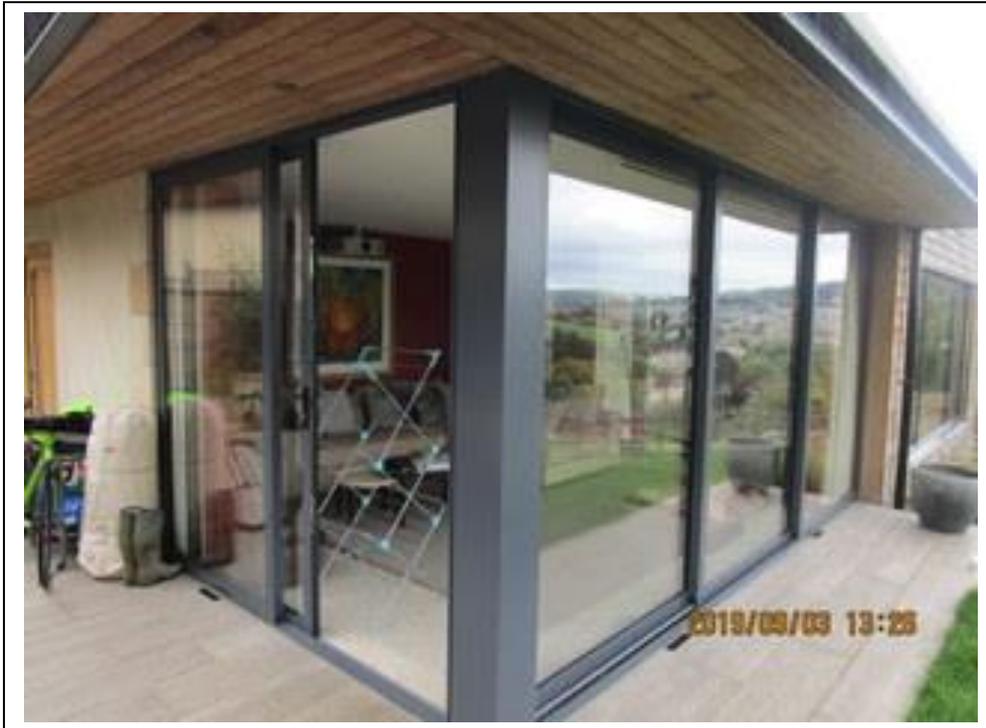
The doors are modern, of a satisfactory quality and they are in satisfactory condition overall.

The sliding doors to the rear extension are modern, of a satisfactory quality and they were working well at the time of inspection.

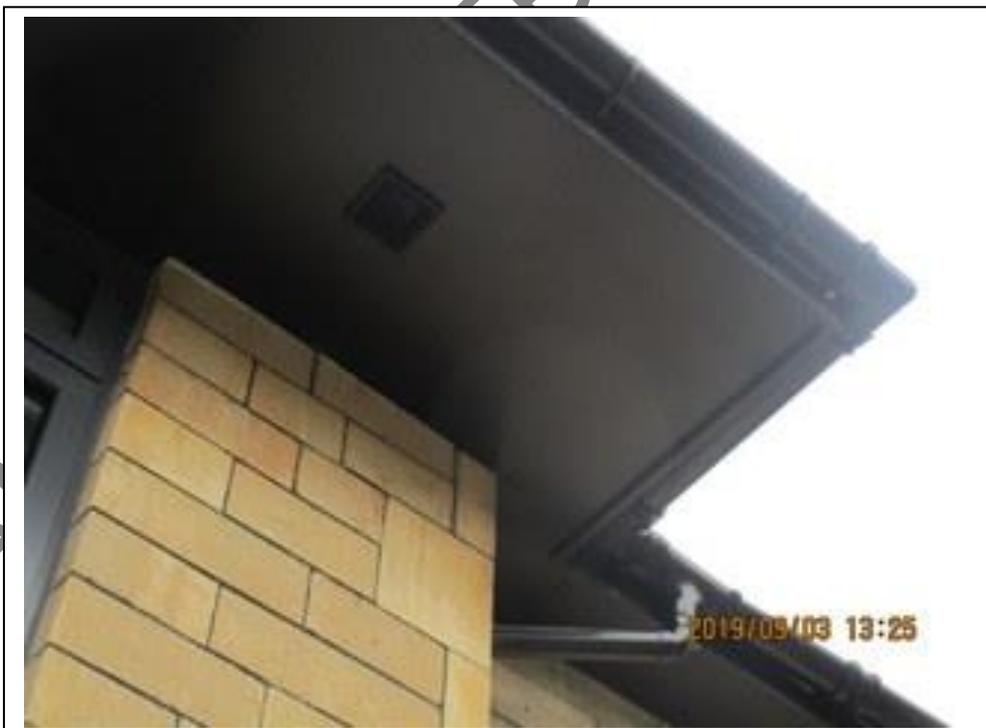
The joinery is modern and satisfactory with no obvious defects noted. Periodic cleaning will help maintain the appearance of the property.

Timber and manufactured board joinery at eaves level.

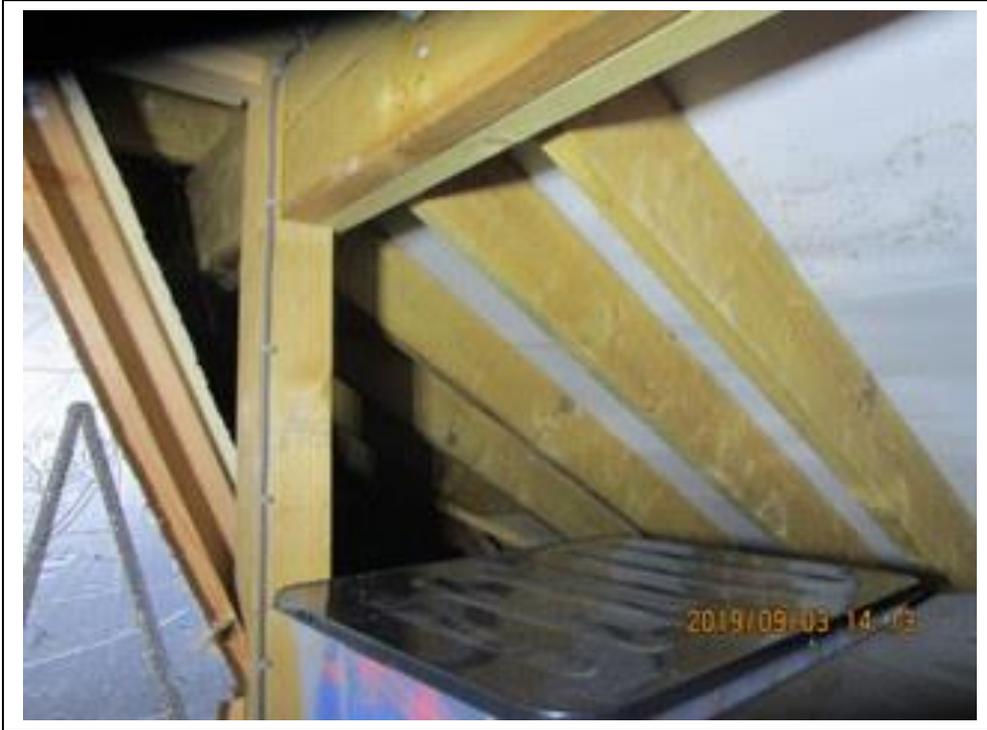
No signs of distortion were noted externally and the roof timbers visible in the main loft were found to be modern and in satisfactory condition. The main rafters measure approximately 140mm x 50mm at around 400mm centres. It appears that the ceiling joists span from front to rear and they should be joined to the feet of the front and rear rafters. There should also be some restraint to the feet of the rafters to the left side although connections were concealed from view.

Roof structure showing modern underlay beneath the tiles.

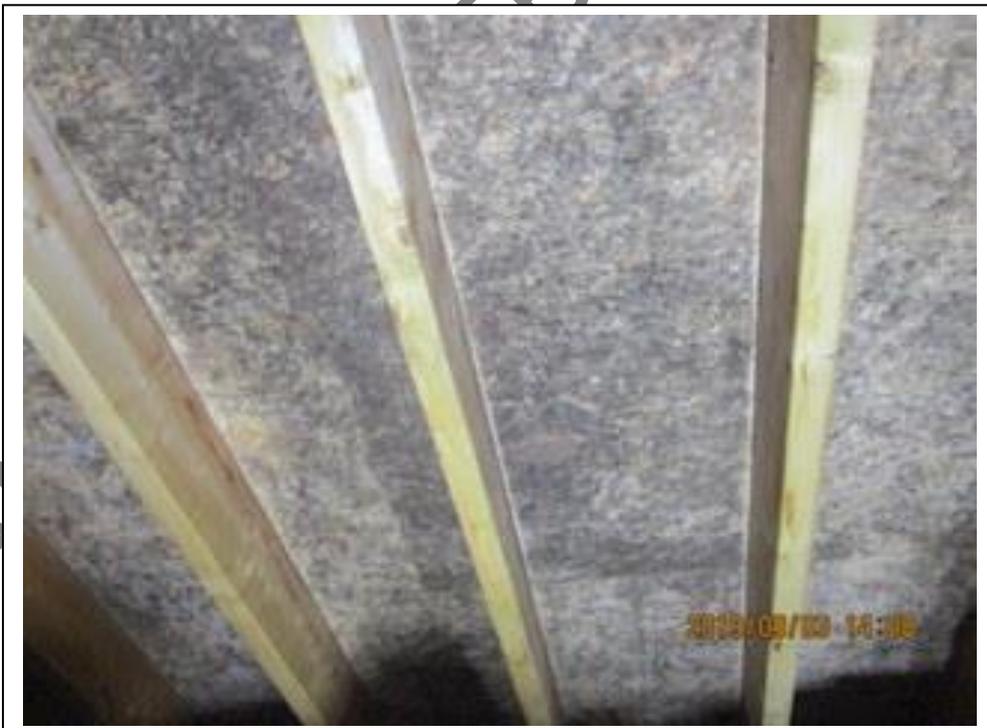
Mould growth noted to the undersides of the flat roof indicates that condensation has been a problem. Mould growth is a potential health risk.

Mould growth to the undersides of the flat roof.

It is recommended that a number of vented roof tiles be installed to promote improved air circulation in the loft. It is also very important to ensure that good ventilation be maintained at all times and that the property be heated consistently during winter, avoiding significant fluctuations or changes in temperature.

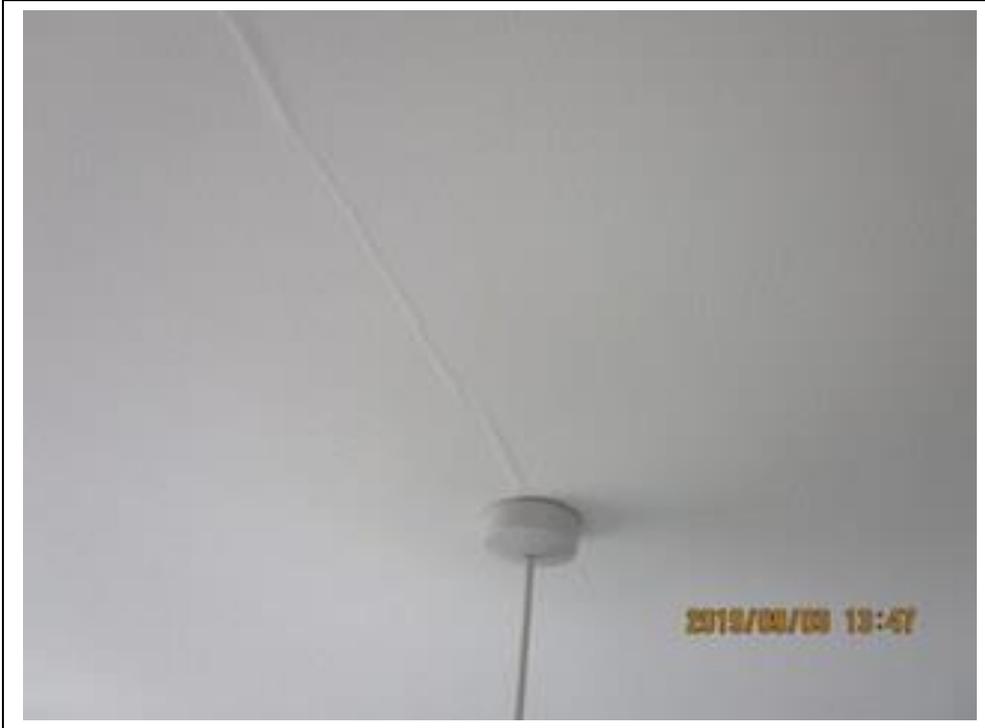
The ceilings are in satisfactory condition with no defects noted.

Ceilings appear to be of mostly plasterboard construction with smooth plaster and papered finishes.

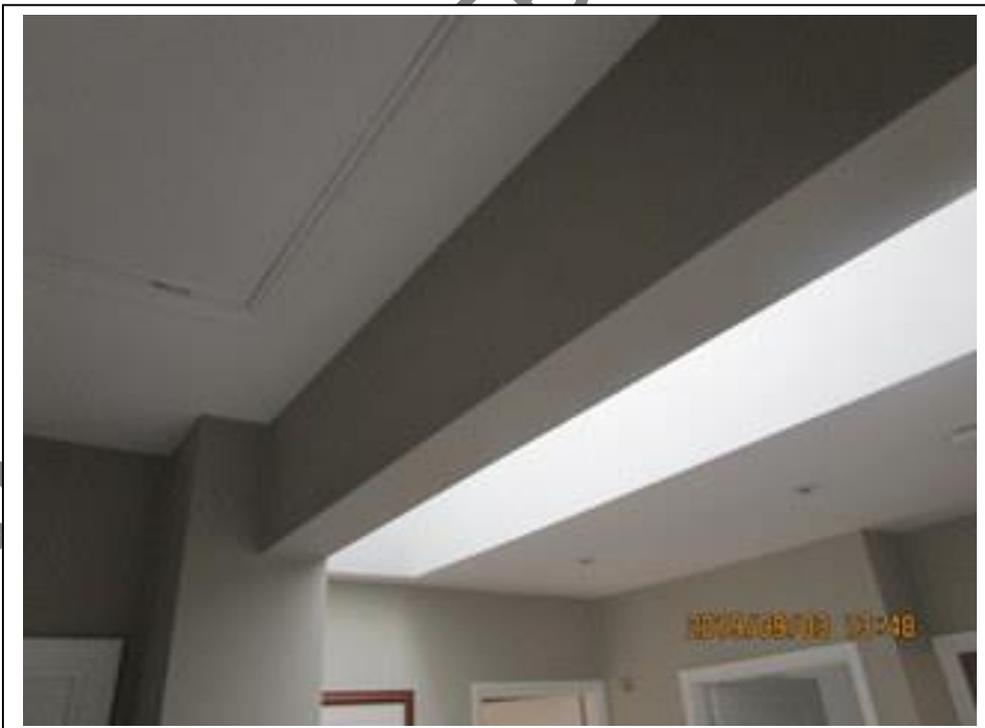
Structural openings have been created in original walls as part of past works of extension.

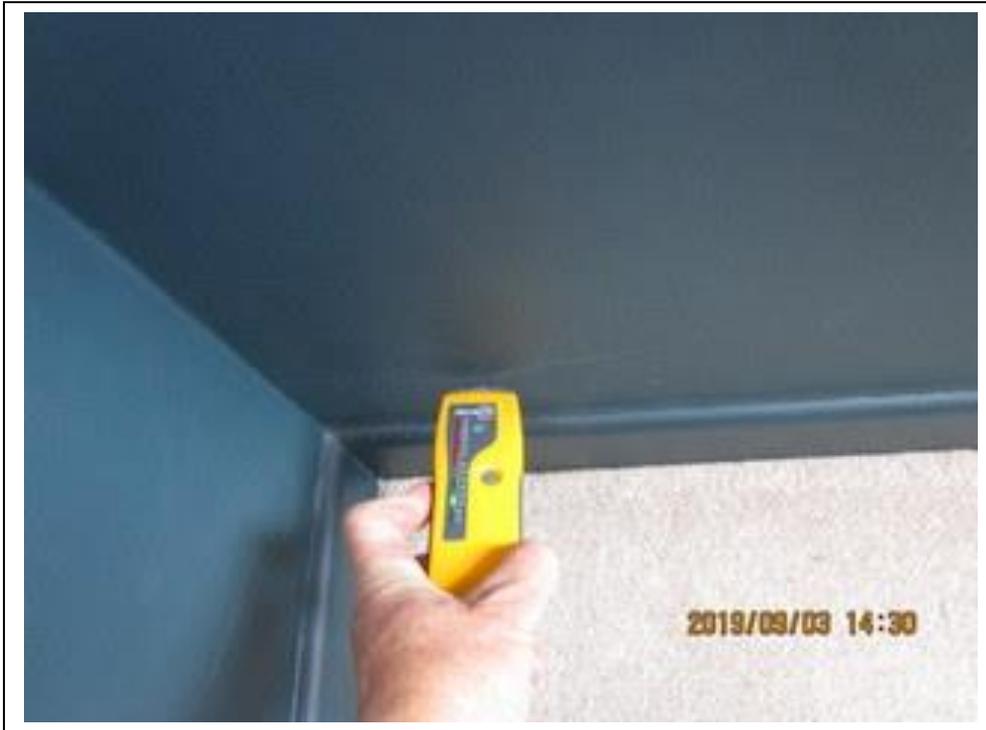
No evidence of rising dampness was noted within the main property. There is no evidence to suggest that the damp-proof course is defective.

No evidence of dampness was noted in the lower walls of the property.

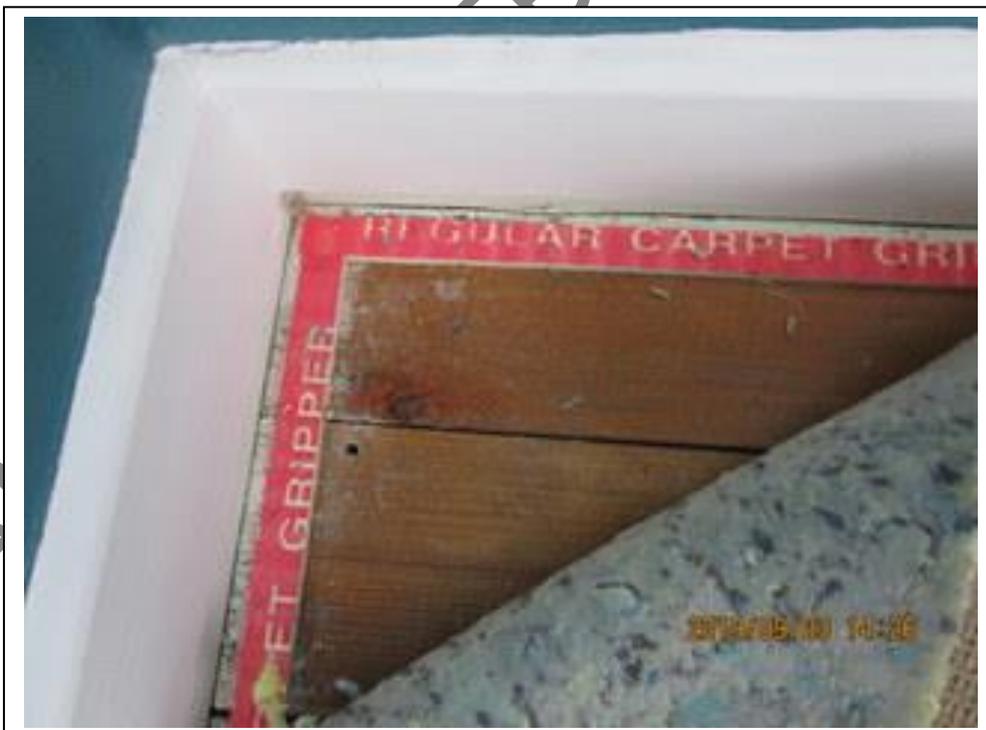
The floors are firm and level with no obvious signs of defects affecting either the modern or older floors within the property.

Floors are of mixed solid and suspended timber construction.

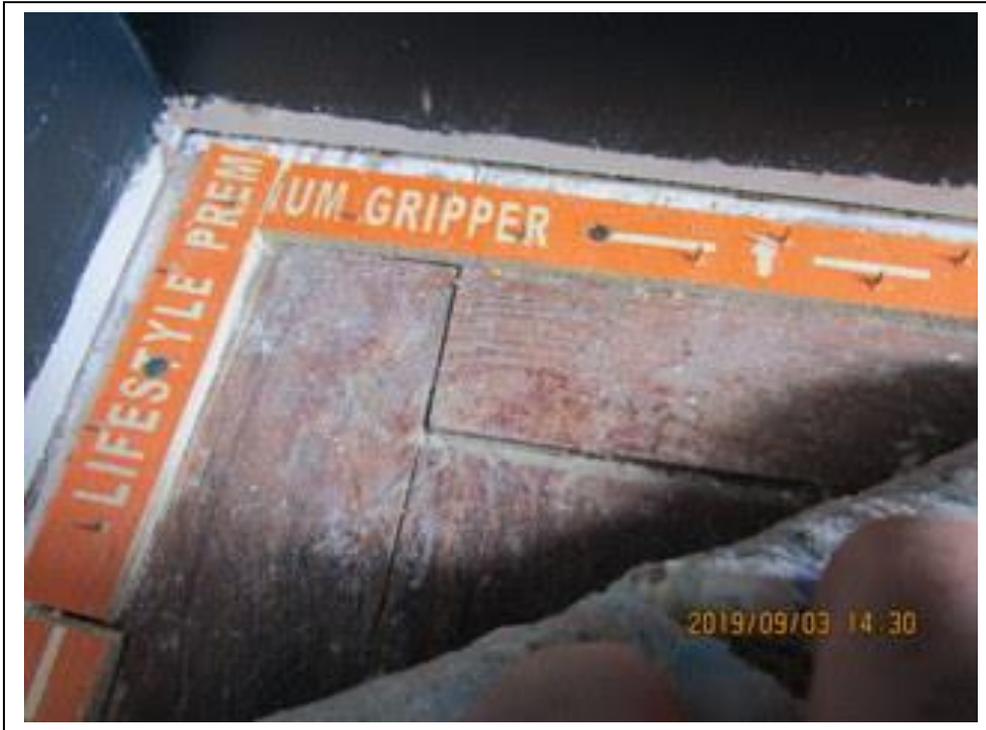
The older solid floors within the original parts of the property may have been built to a less satisfactory standard than the modern floors and it was noted that the floors are of a significant depth in some areas and could be vulnerable to settlement. No signs of problems were noted. The older solid floor in the sitting room to the front left has a wood-block finish beneath carpet and underlay.

The older solid floor in the sitting room to the front left has a wood-block finish beneath carpet and underlay.

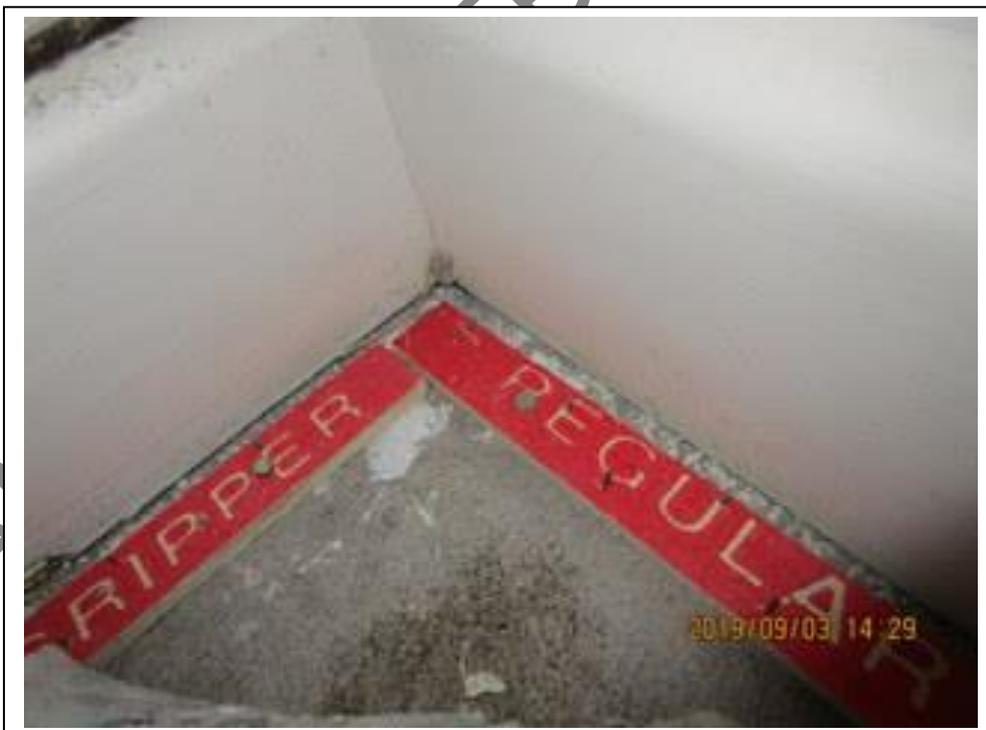
Concrete screed to the floor in the front of the extension at ground floor level.

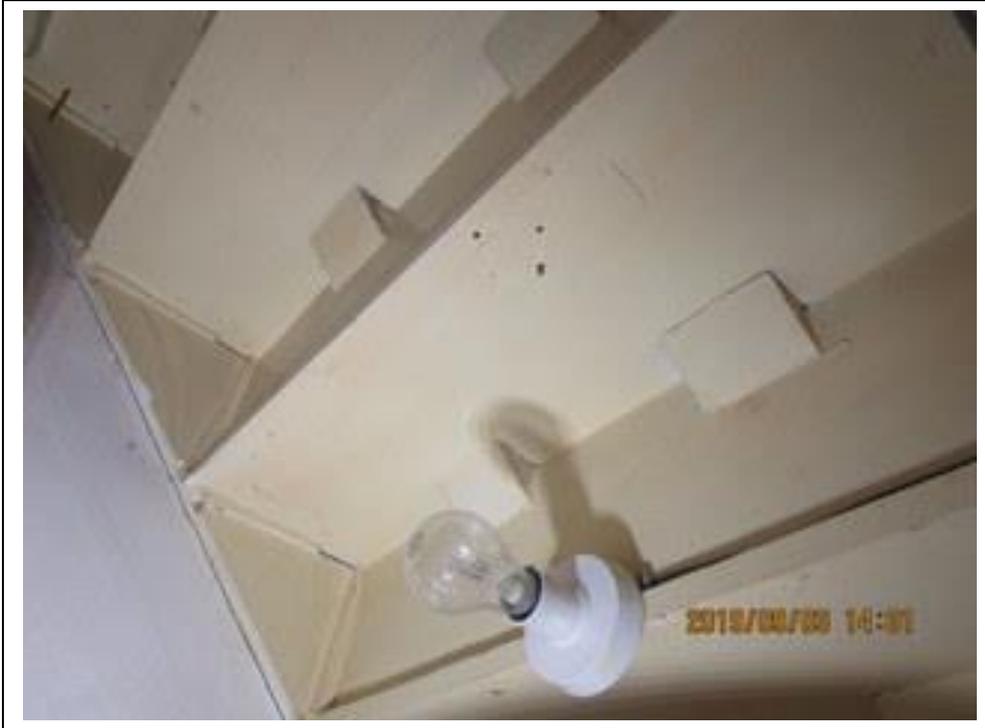
Stairs are firm underfoot with no obvious signs of problems noted when viewed from beneath.

Stair timbers viewed from beneath.

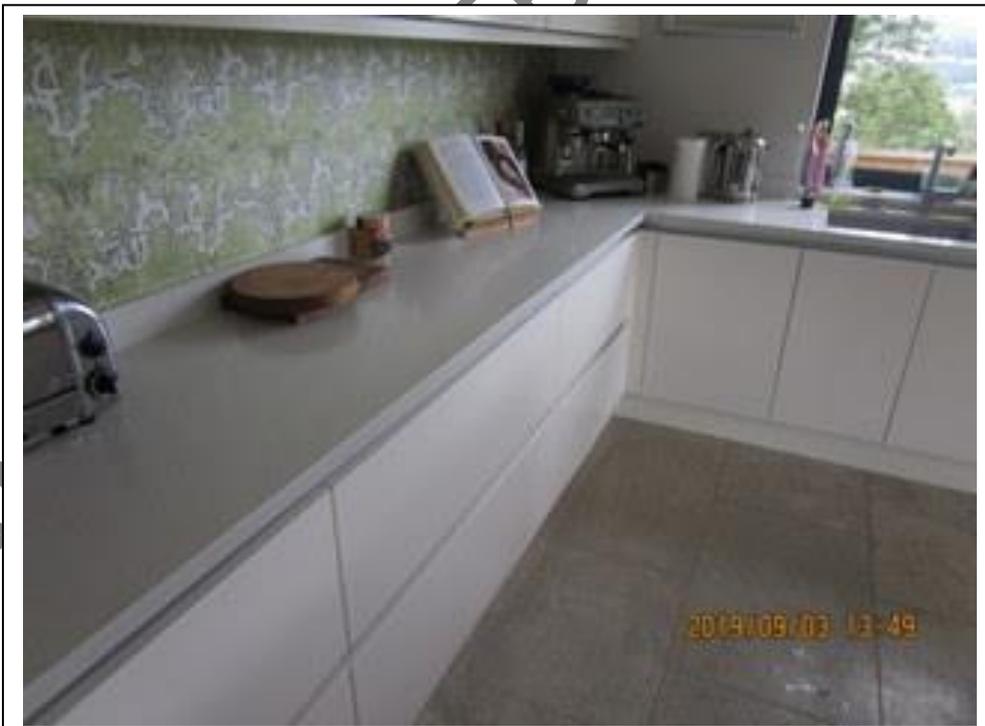
The fittings are modern and they are in satisfactory condition.

Kitchen cupboards.

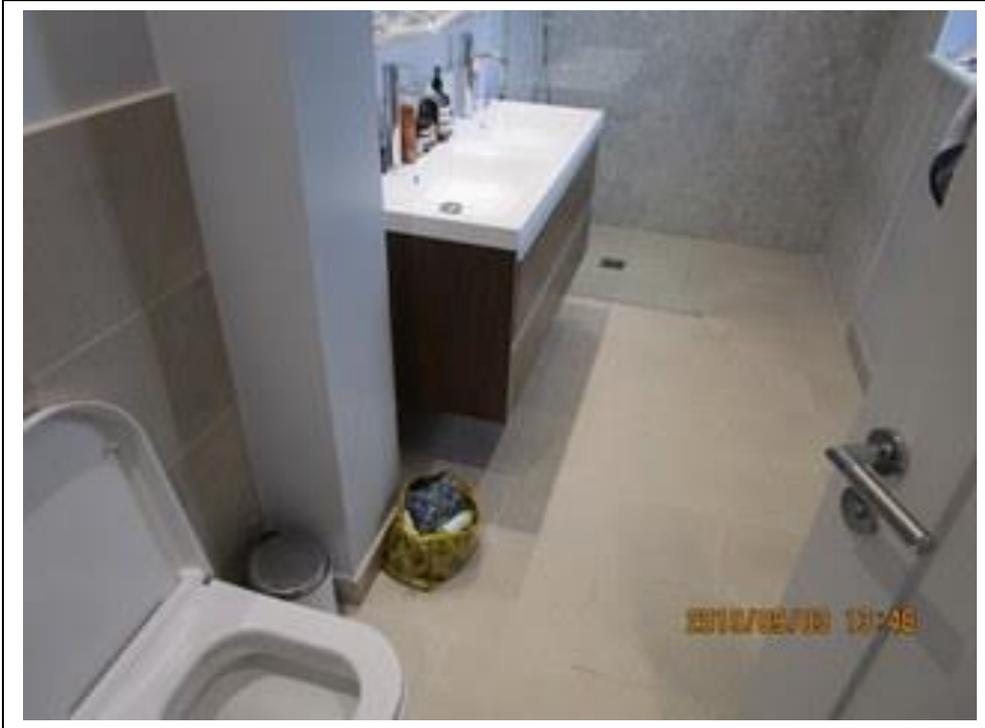
The shower does not incorporate a conventional tray and any future problems relating to the waterproof membranes beneath the tiles in the shower area could result in leaks which would be difficult to repair.

Sanitary fittings in the en-suite shower room.

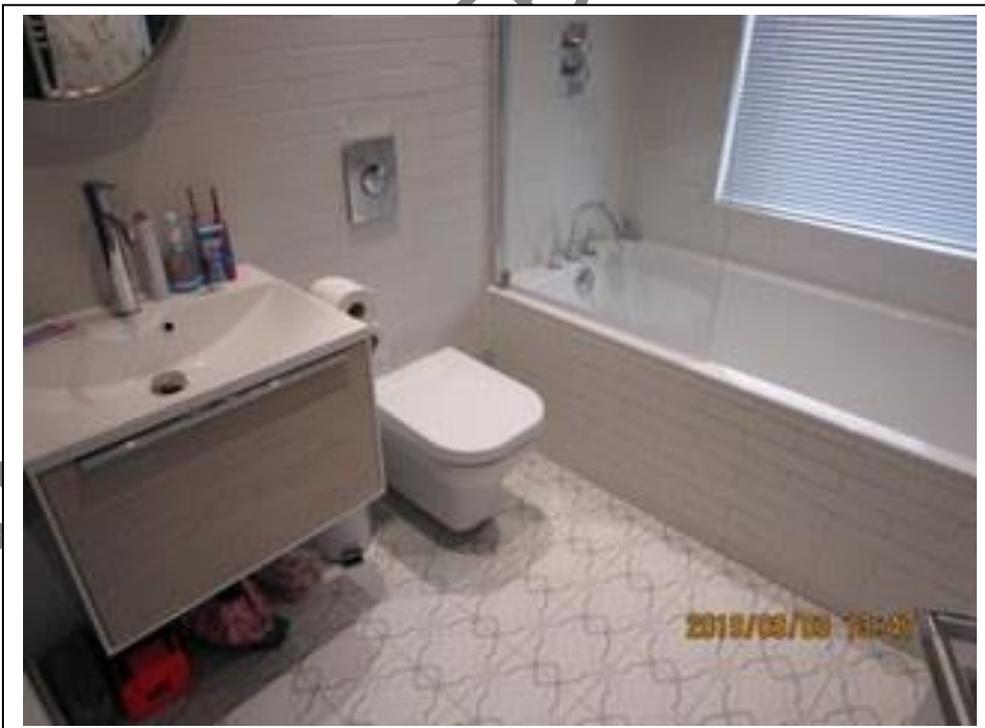
The fittings are modern and in satisfactory condition. The shower, WC and washbasin were working correctly at the time of inspection with no obvious signs of problems noted.

Bathroom.

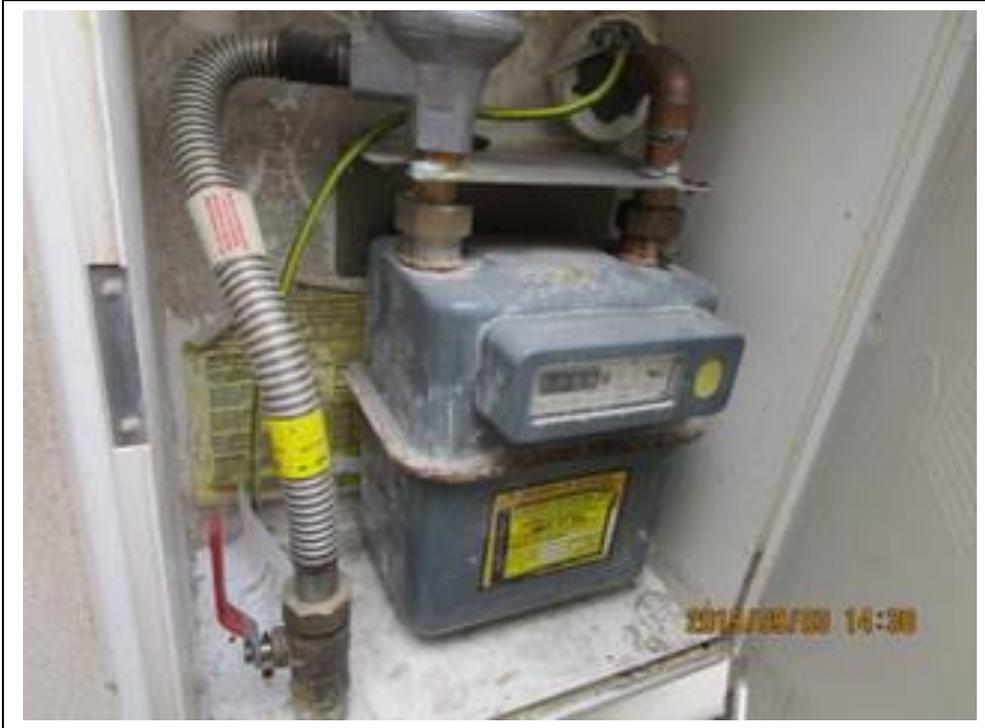
The gas meter has a secure bracket fixing to the wall, pipes are of copper construction with an electrical earth connection and no smell of gas was noted. The meter itself is relatively old.

Gas meter with secure bracket fixing and electrical earth connection.

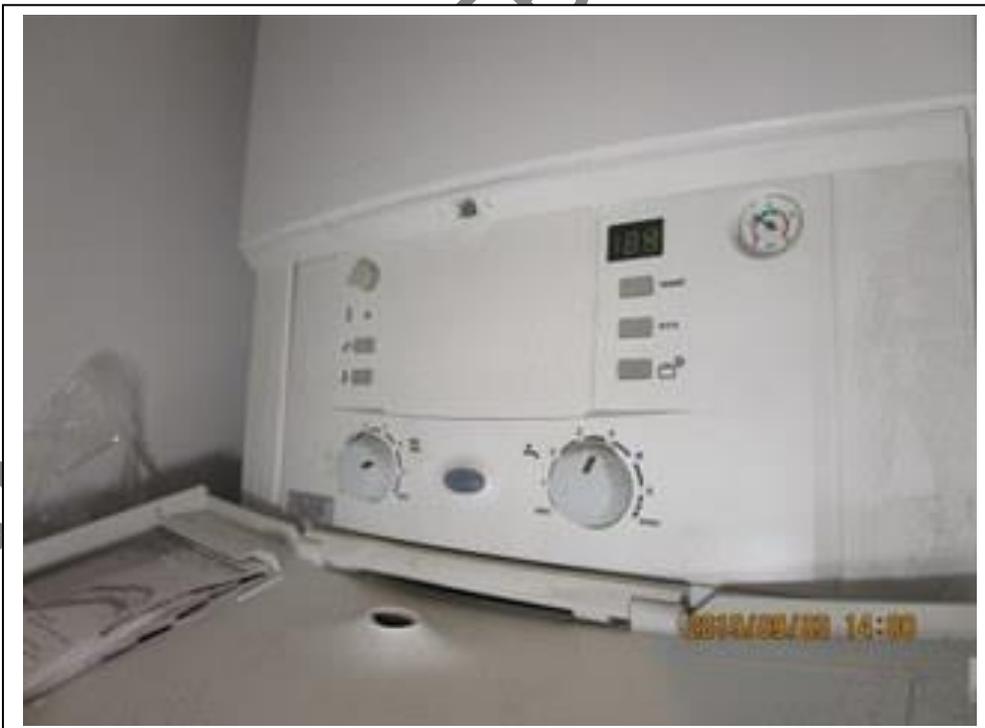
The 'Worcester' central heating boiler located in the utility room.

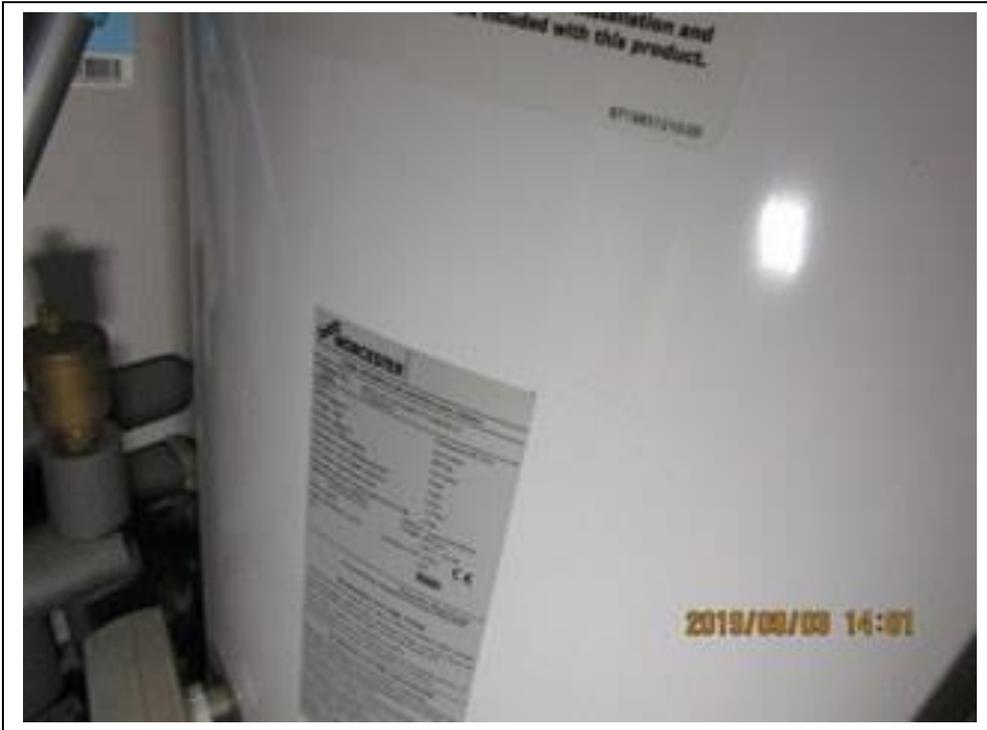
There is a large (216l) pressurised hot water storage tank located in the under-stairs cupboard. The tank appears to be in satisfactory condition and it should be able to supply several outlets simultaneously at reasonable pressure.

The hot water storage tank.

The tank operates at pressure and it should be checked annually when the boiler is serviced or otherwise in accordance with the manufacturers' recommendations.

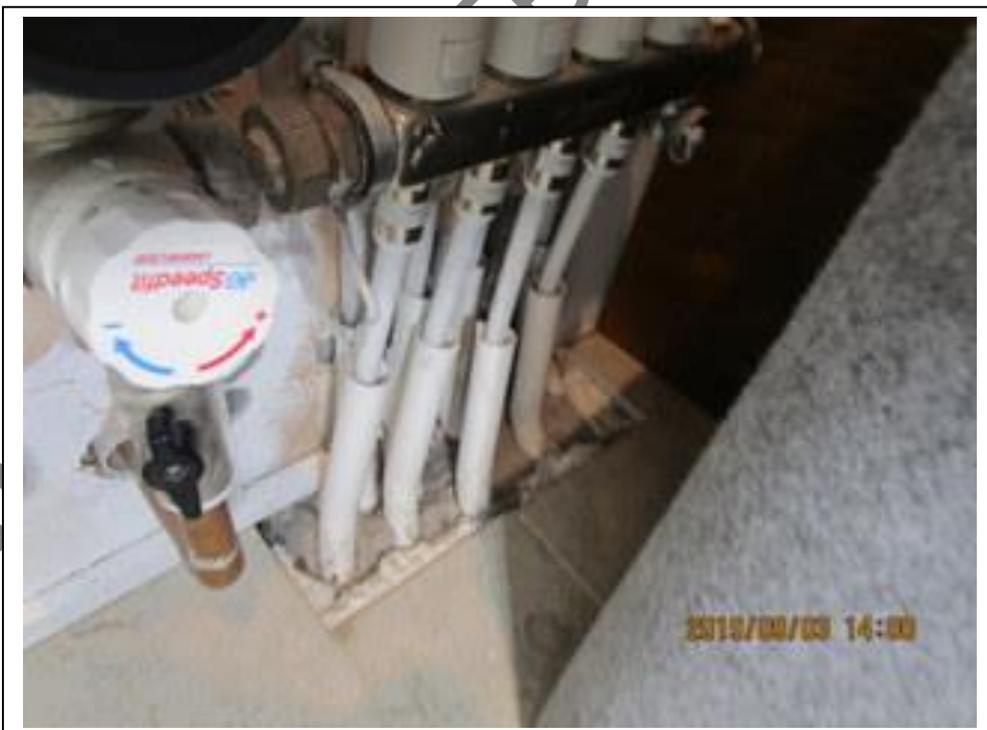
Underfloor heating is best operated at a fairly low level but on a continuous basis during winter months. Any significant fluctuations could result in cracking to floor tiles and underfloor heating tends to take longer to increase room temperature than a conventional radiator system.

Underfloor heating manifold and pipes.

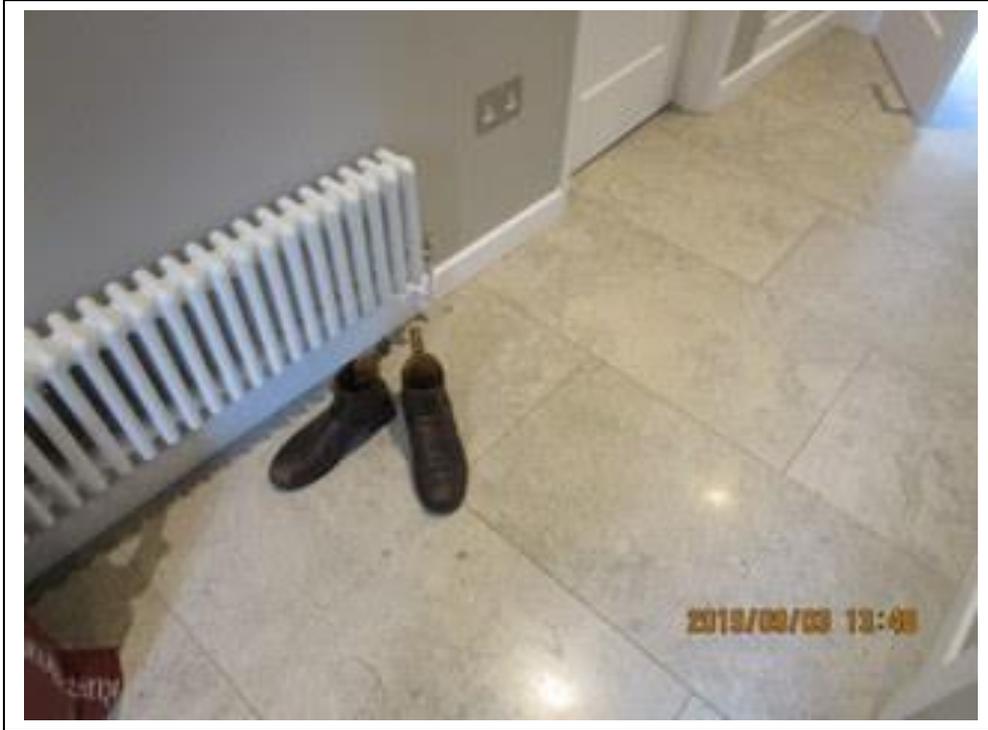
Radiator in the hall.

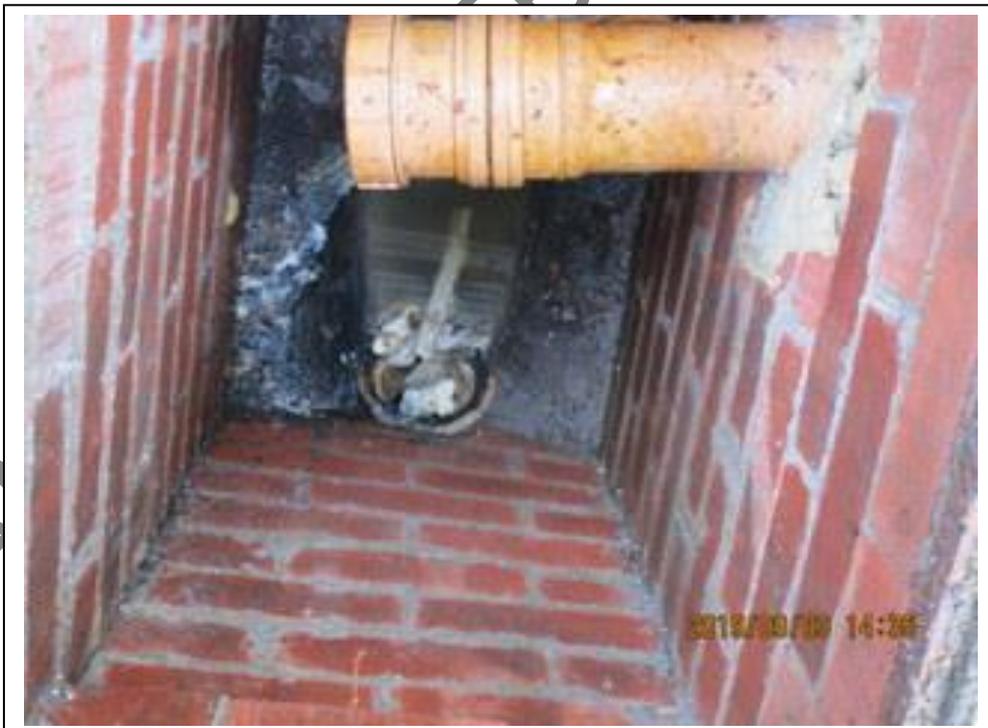
Most of the underground pipes were hidden from view and could not be checked, however there are some signs of blockage in the inspection chamber to the front left. The blockage should be cleared and it would be prudent to obtain a CCTV drainage test to provide further information in relation to the condition of underground pipes. Old pipes may not be fully watertight and the need for repair cannot be ruled out.

Debris within the drainage pipes to the left side of the property.
