Chartered Surveyors

Sample Building Survey (Level Three Report)

**A Building Survey
on
Brockley
Bristol
BS48**

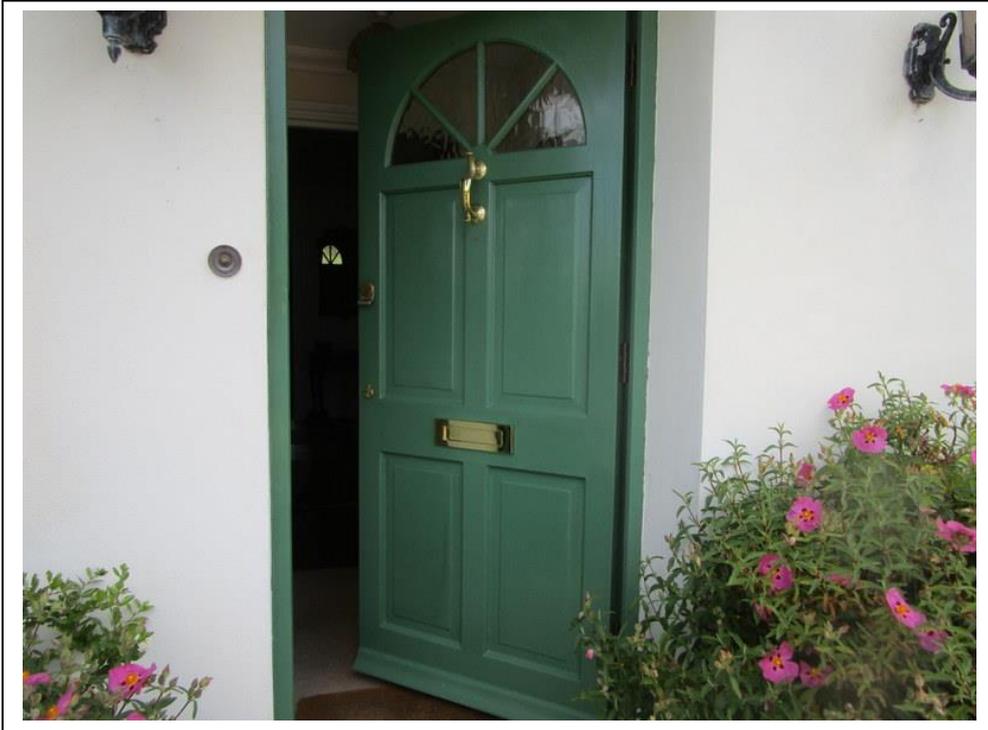
Front door.

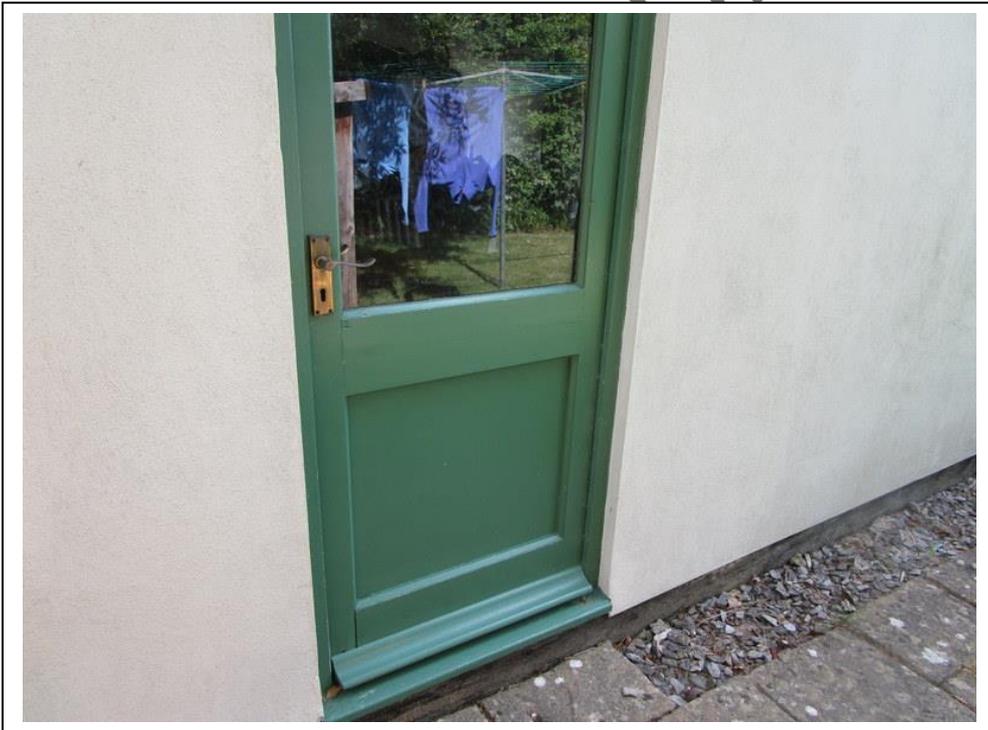
Side door to the garage.

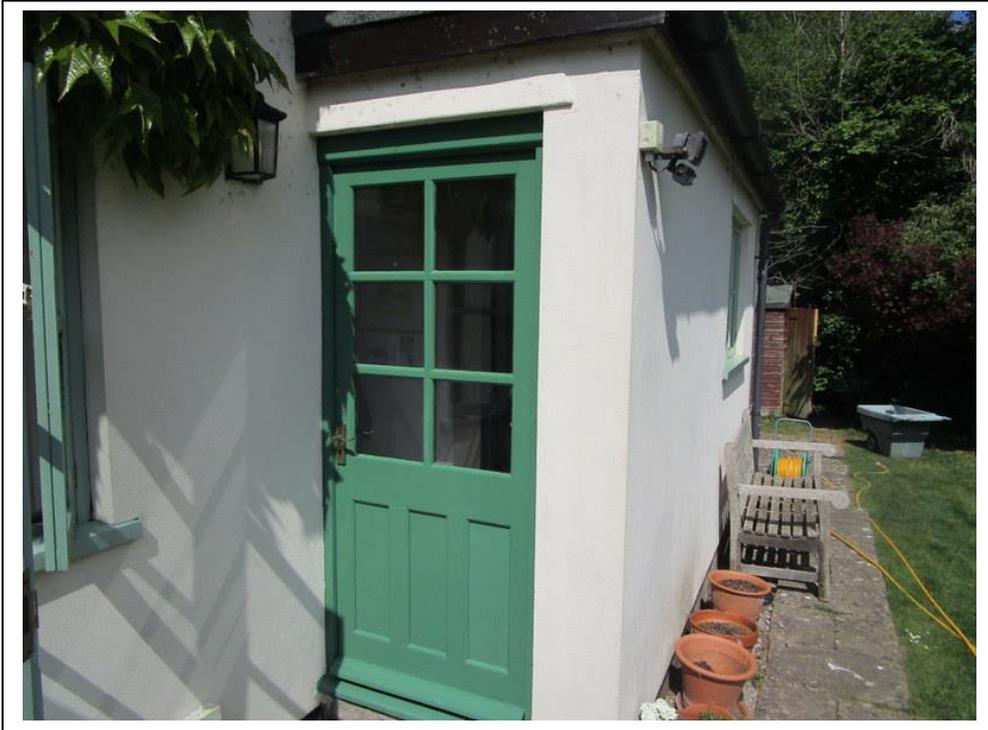
Rear door to the utility room.

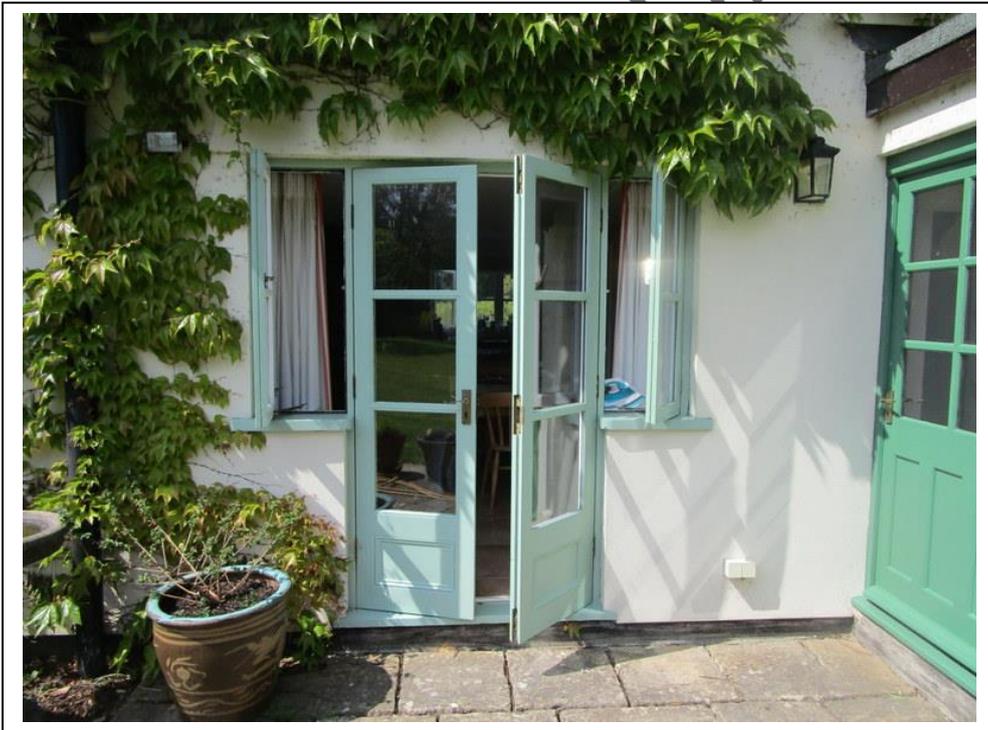
Glazed French doors to the rear of the breakfast area.

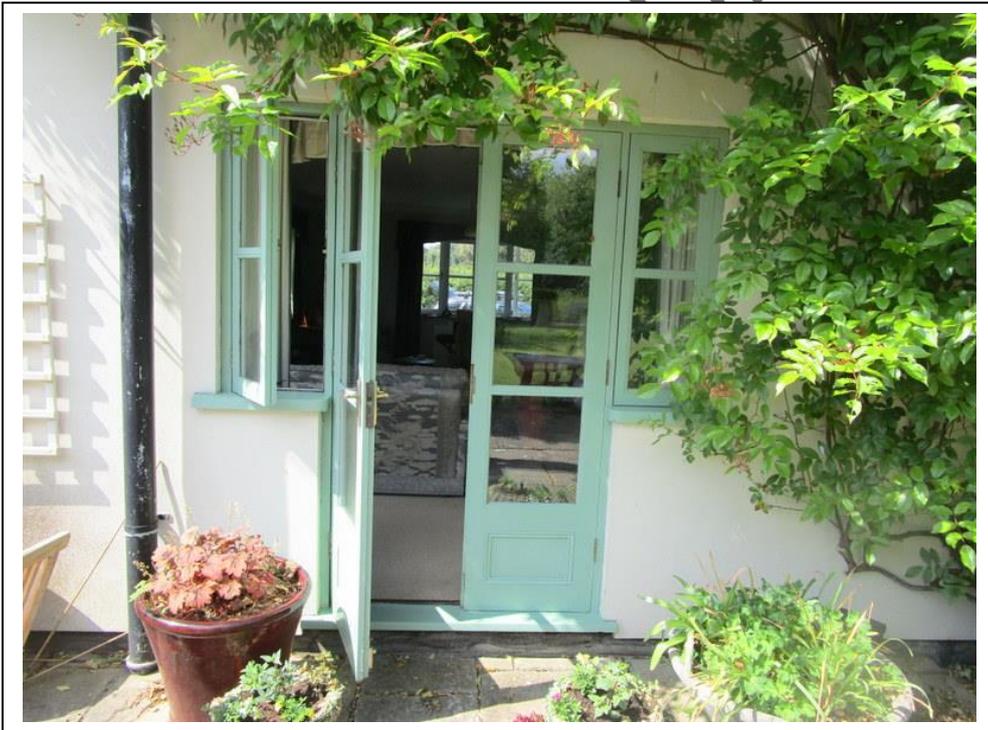
Doors to the rear of the sitting room.

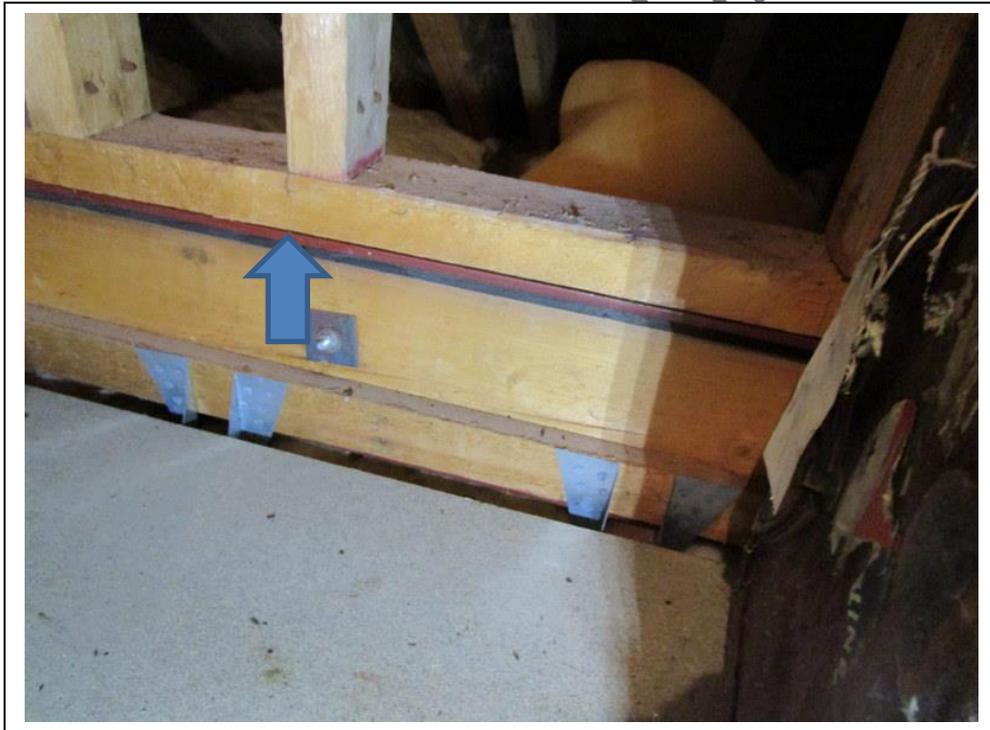
One of several steel beams visible in the loft and eaves areas.

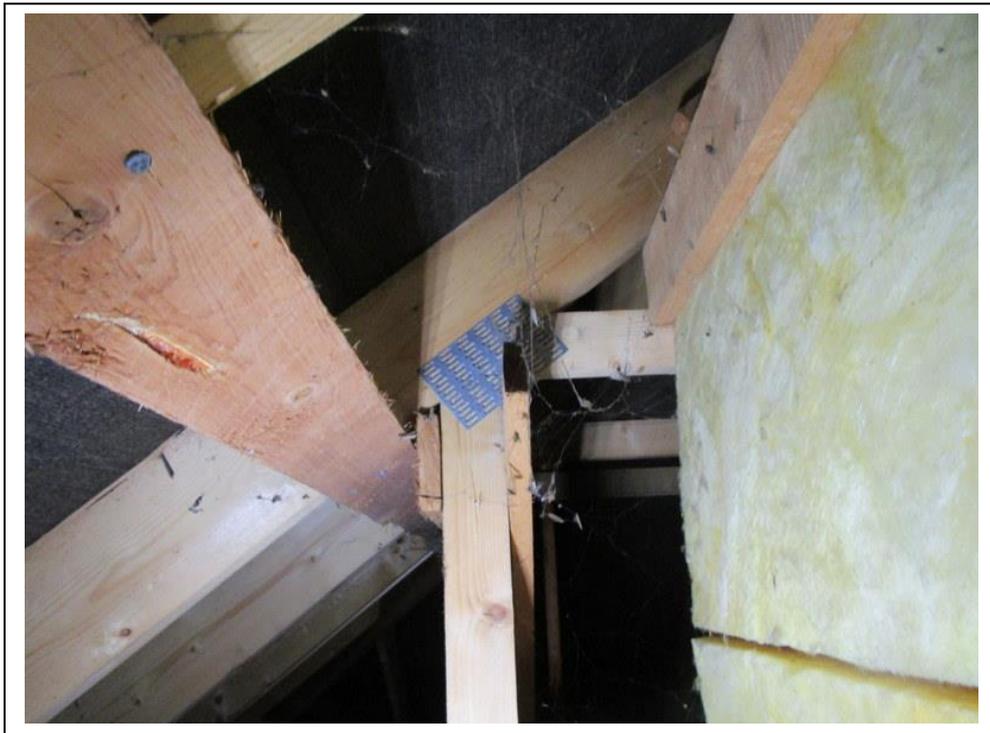
The central section of the roof is of timber truss construction. The roof trusses were designed to facilitate construction of the loft bedroom.

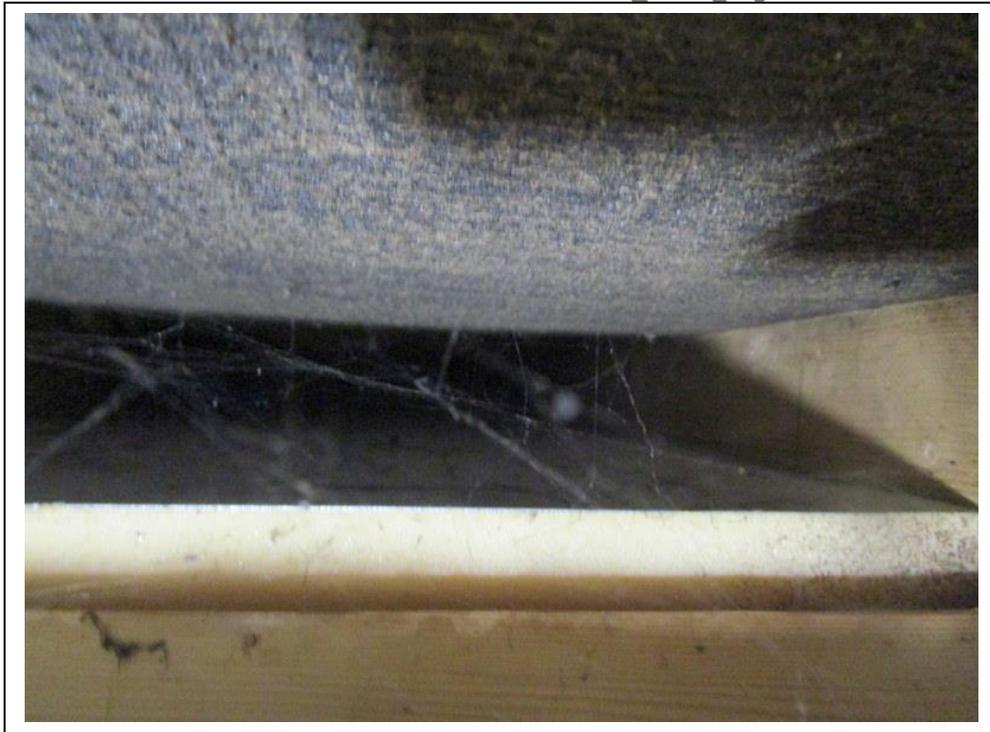
Board insulation fitted between the roof trusses showing ventilation pathway designed to help avoid condensation.

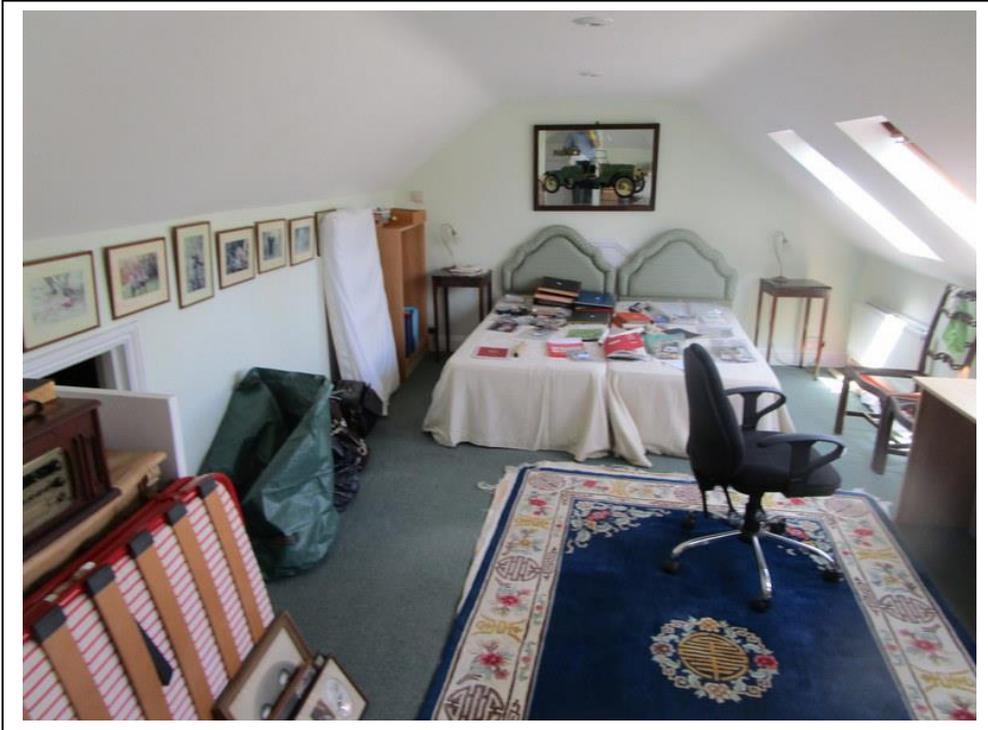
Loft bedroom visible internally showing plasterboard ceiling finishes.

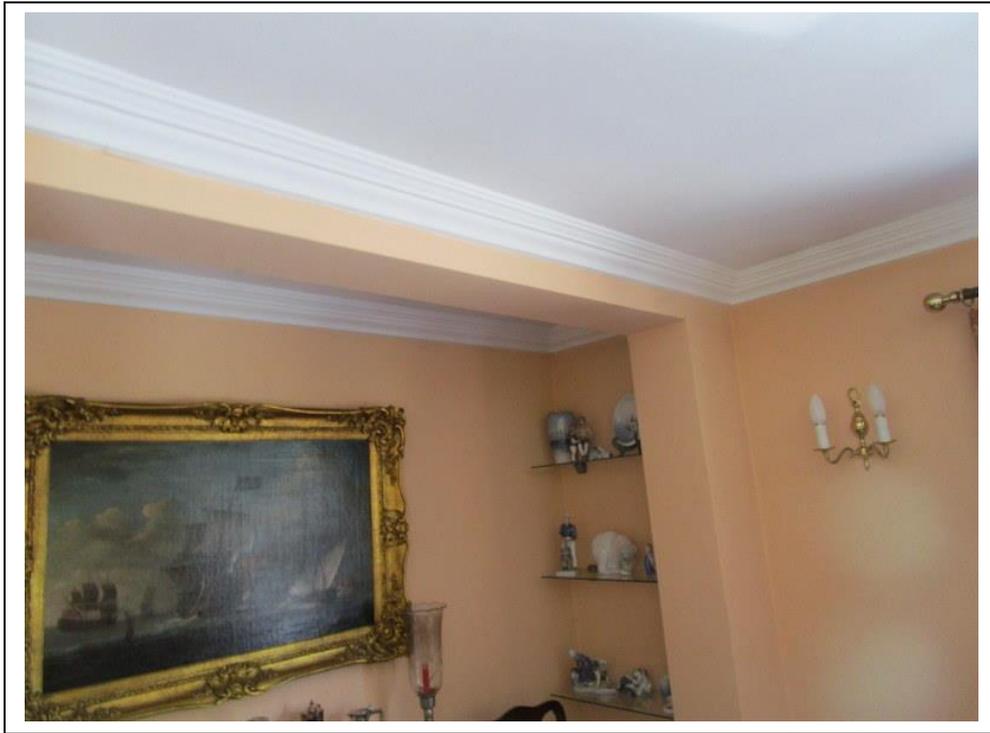
Structural openings have been created in a number of the internal walls as part of past changes in the layout of the property.

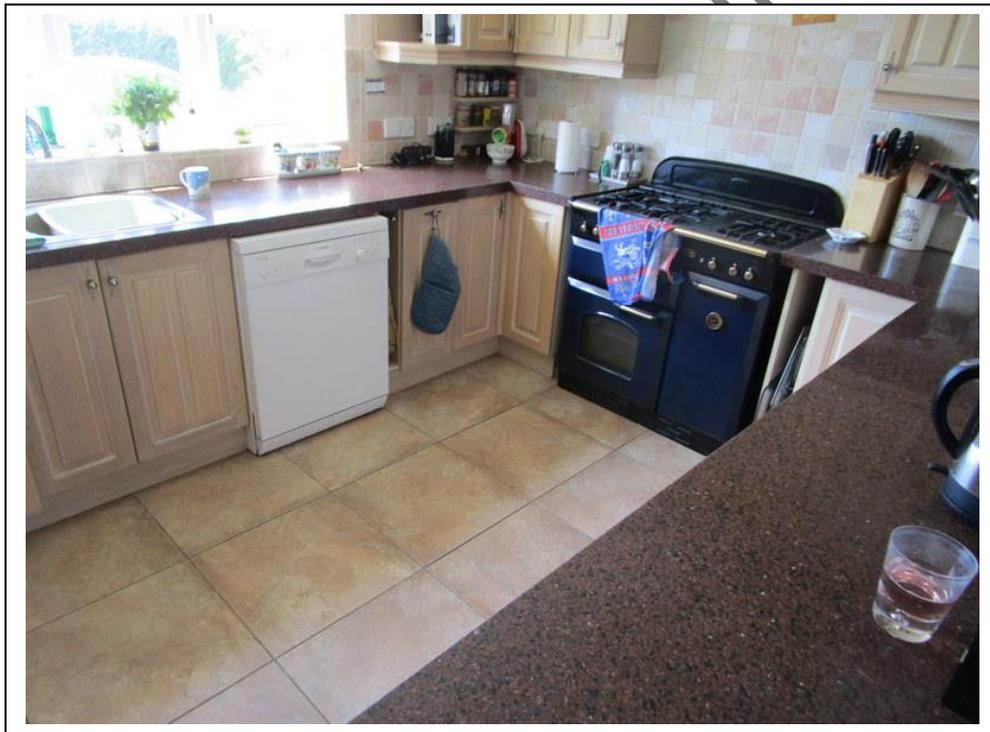
Kitchen fittings showing gas range cooker and solid floor with tile finish.

Internal joinery to doors, skirtings etc is largely satisfactory although kitchen and sanitary fittings are now dated and you should plan for replacement in the medium term.

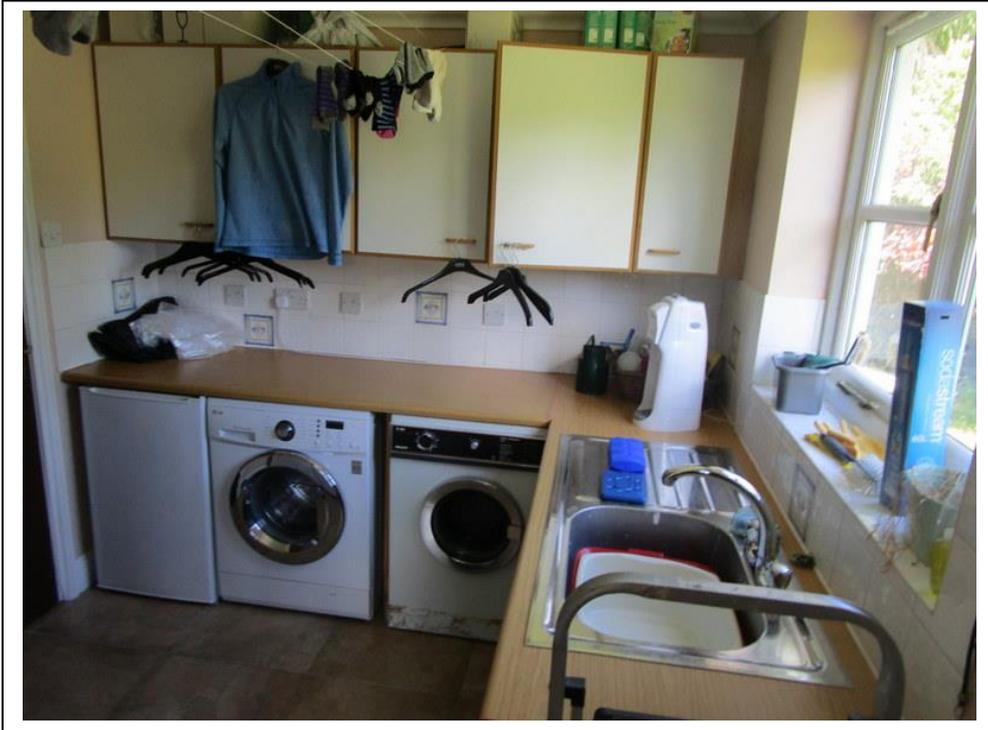
Fittings in the utility room.

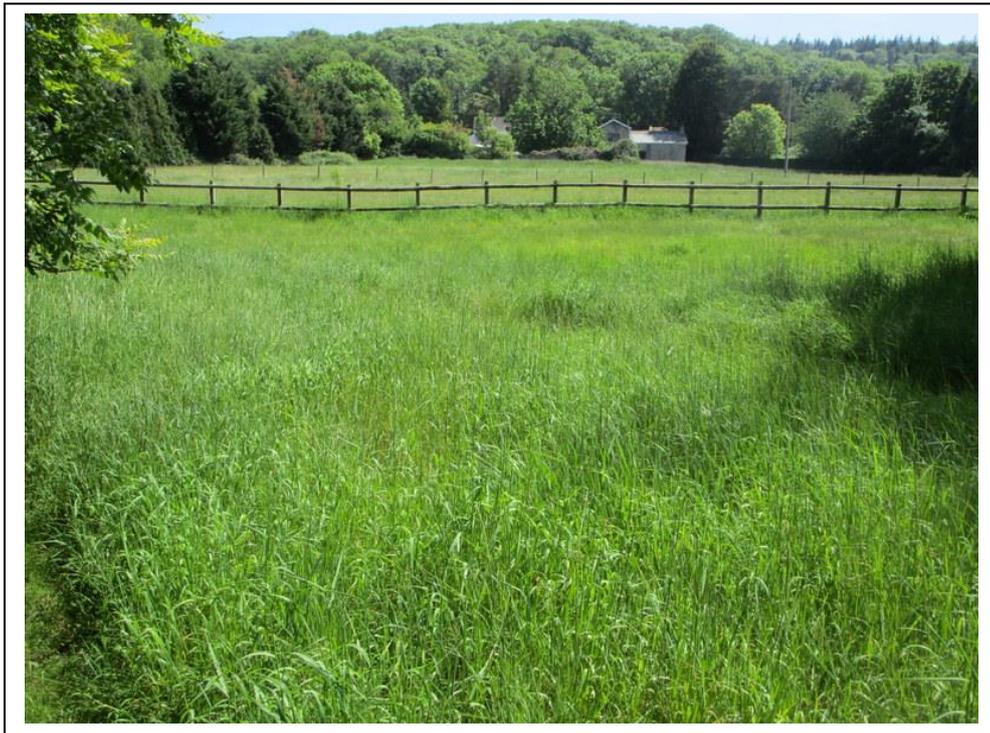
Gardens and boundary fence to the right rear.

The fencing should be repaired in the short term and replaced in the medium term.

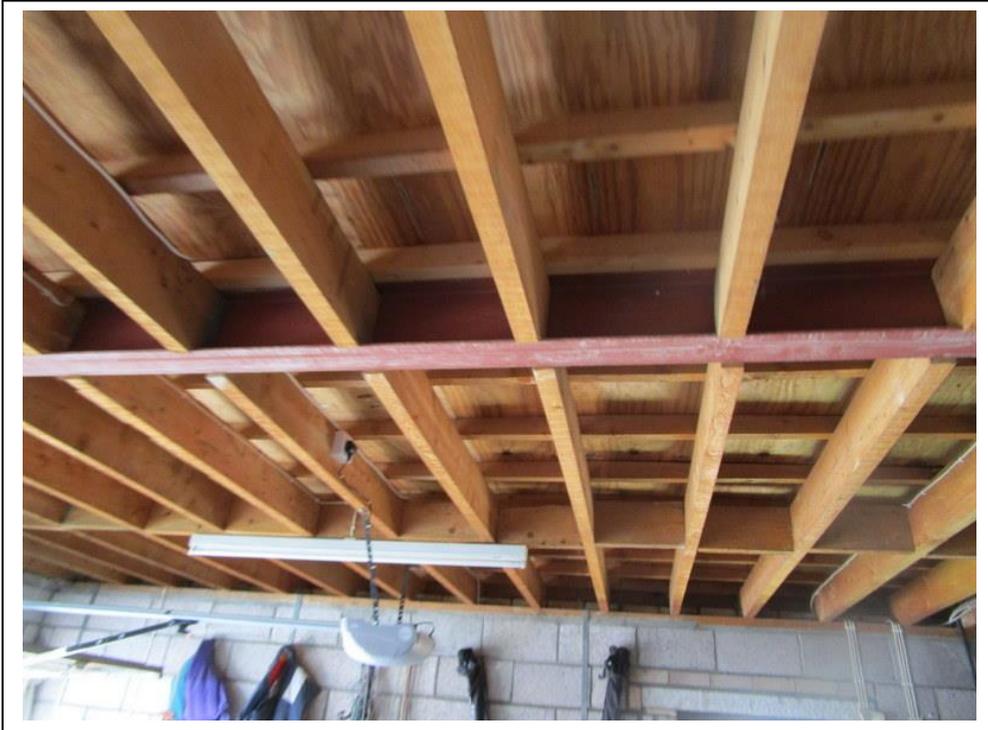
Garage roof structure showing timber joists and steel beam. The roof construction is satisfactory.
